ASSET MANAGEMENT PLAN

OC San owns and operates wastewater collection system infrastructure, as well as two resource recovery and wastewater treatment facilities, located in Fountain Valley and Huntington Beach. Our collection system infrastructure includes 388 miles of regional trunk sewer pipelines and 15 pump stations located throughout the OC San service area (Figure ES-1-1). Wastewater is conveyed to Reclamation Plant No. 1 in Fountain Valley and Treatment Plant No. 2 in Huntington Beach. These facilities treat an average daily wastewater flow of 180 million gallons per day (MGD), serving over 2.6 million people in central and northern Orange County, California.

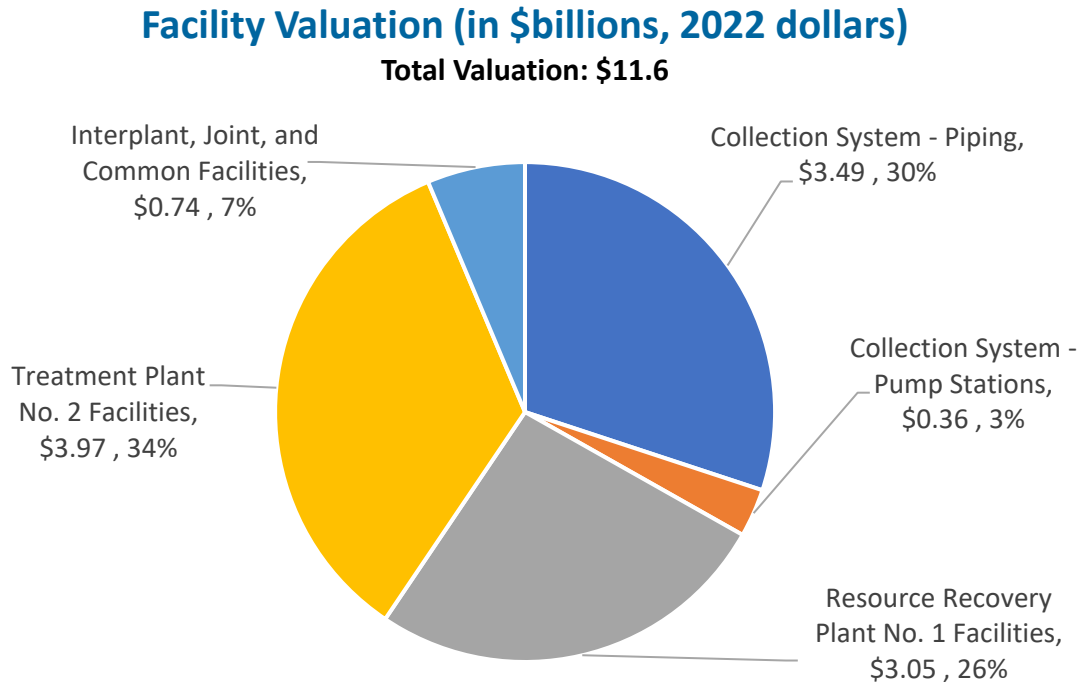
Figure ES-1-2. Facility Valuation by Location

Figure ES-1-2 shows the facility valuation by asset system for OC San's wastewater infrastructure. The valuation was prepared as part of the 2017 Facilities Master Plan. The estimated replacement value in FY 2022-23 is \$11.6 billion based on the Engineering News Record Construction Cost Index (CCI) increases since the 2017 Facilities Master Plan.

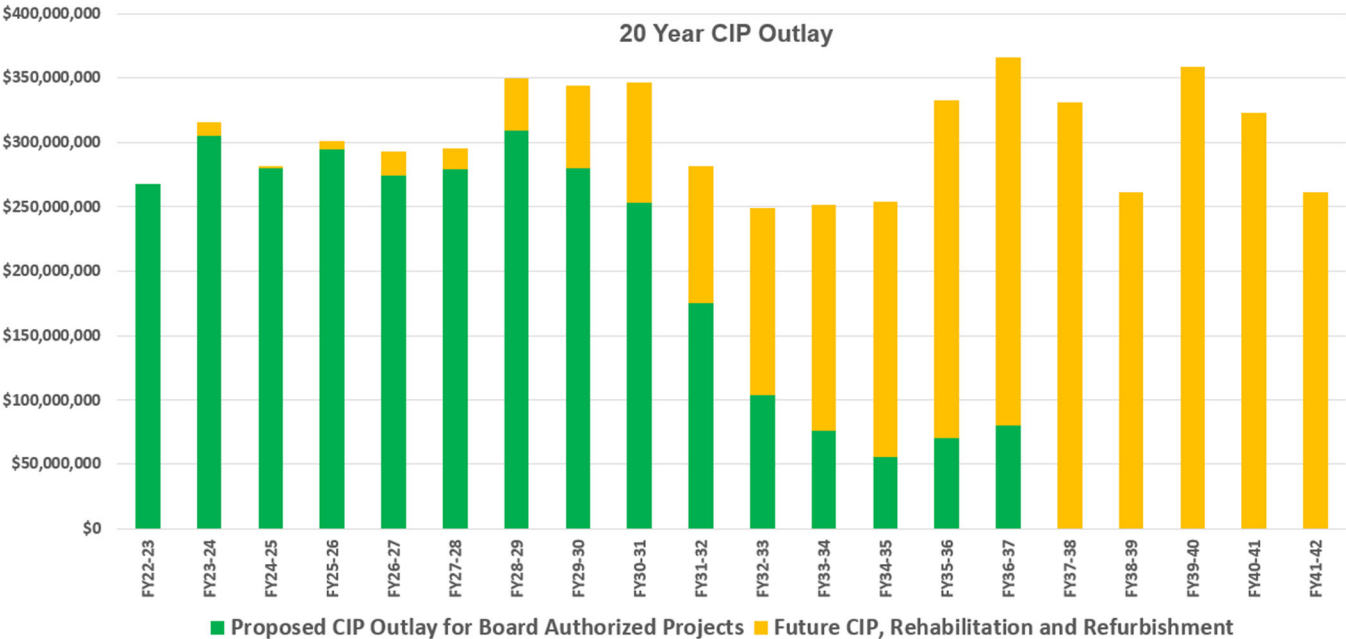
Figure ES-1-7. 20-Year CIP Outlay

Fiscal Year (FY) 2022-2023 Budget Update, the first year of the two-year budget adopted in June 2022, includes updates to the 20-year Capital Improvement Program (CIP) outlay. Figure ES-1-7 includes current and projected CIP projects.

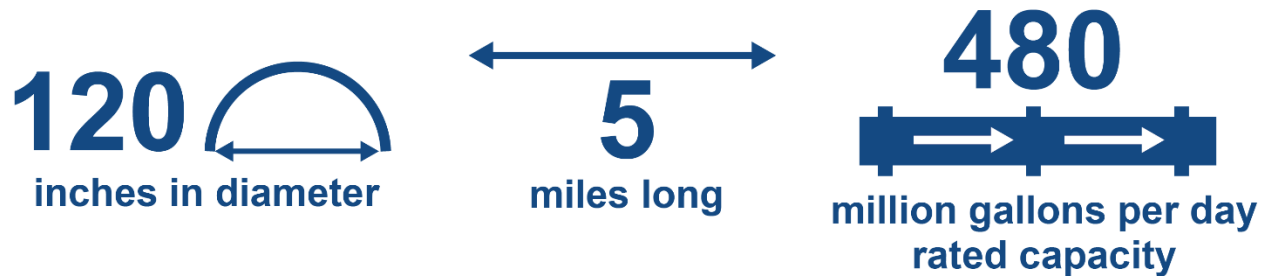
OUTFALL NO. 2 PRIMARY OCEAN OUTFALL

Outfall No. 2 serves as the primary ocean outfall, discharging treated wastewater approximately 5 miles offshore at a depth of approximately 200 feet. It began service in 1971 and is currently undergoing a comprehensive assessment and will undergo a rehabilitation to ensure its reliability for many years to come.

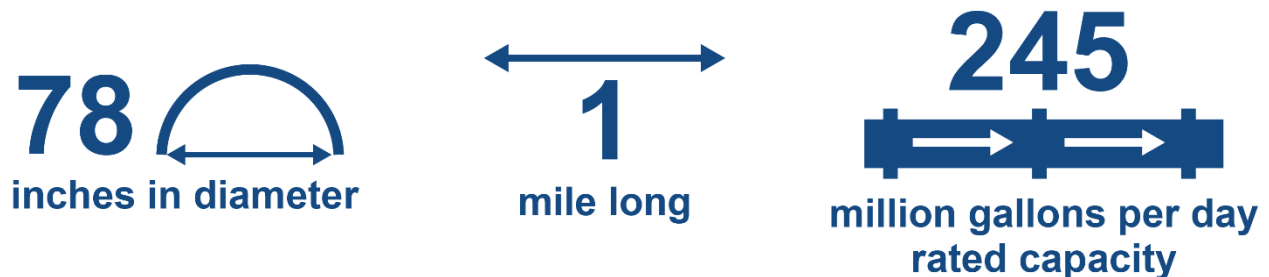
OUTFALL NO. 1 EMERGENCY OUTFALL

Outfall No. 1 serves as an emergency outfall and primary backup to Outfall No. 2, discharging treated wastewater over a mile offshore at a depth of approximately 65 feet. It was originally constructed in 1954 and was later modified in 1965. It is located over a mile offshore at a depth of approximately 65 feet and serves as a primary backup to Outfall No. 2. OC San's NPDES permit specifies that this outfall can only be used in the case of an emergency or during planned maintenance activities. This outfall will also go through a comprehensive assessment in the near future.

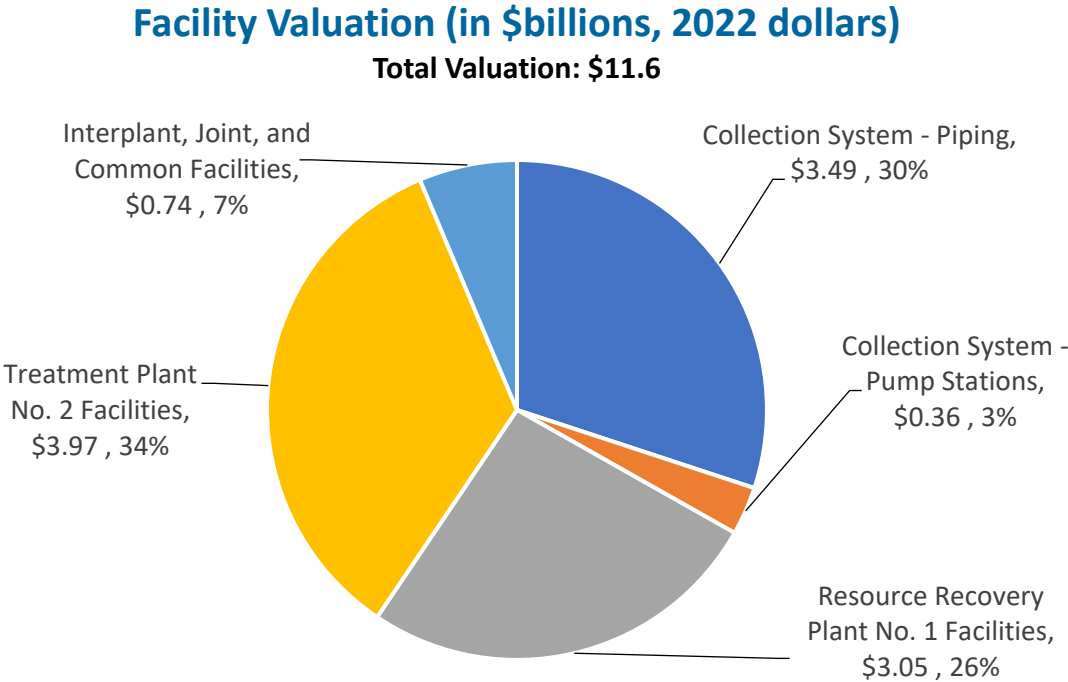
Figure 1-2. Facility Valuation by Area

Figure 1-2 shows the valuation information, presented in five general sub-process areas:

- Collections Systems Piping;
- Collection Systems Pump Stations;
- Reclamation Plant No. 1 Facilities;
- Treatment Plant No. 2 Facilities; and
- Interplant, Joint, and Common Facilities.

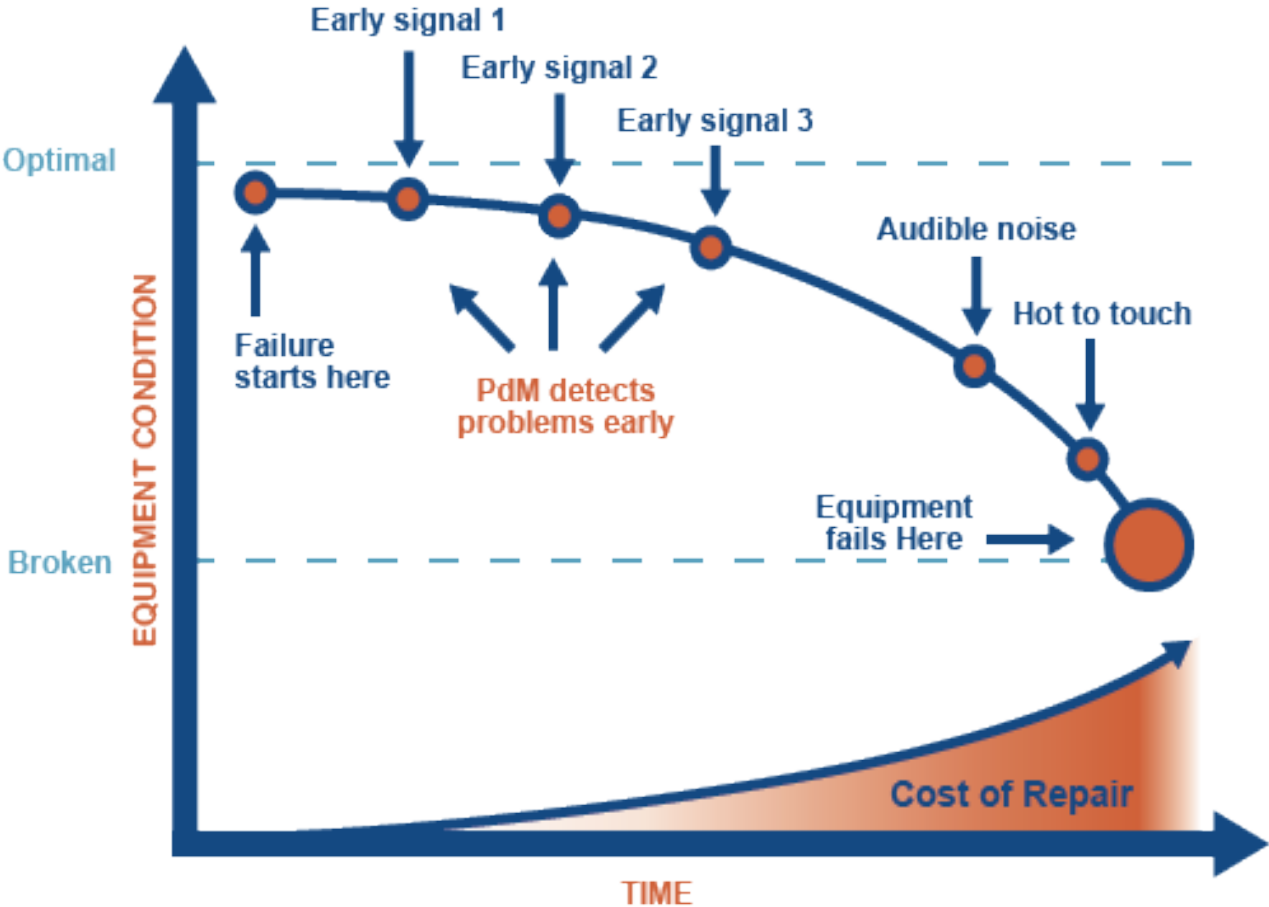
Figure 1-4. PdM Summary

In asset management, Predictive Maintenance (PdM) strategies are used to regularly monitor the condition of assets. OC San's Maintenance Reliability Group implements the PdM Program, which collects data through condition monitoring, enabling the real-time performance of assets. The premise of PdM is a proactive approach to minimize unexpected breakdowns, reduce repair cost, extend the Mean Time Between Failure (MTBF), monitor the actual equipment health through quantifiable means, and perform advanced analysis and failure detection. In addition, when sudden changes or variations in the process manifest, they are often found during the regular Maintenance Reliability rounds as part of their everyday work. The ability to monitor equipment lends itself to helping Maintenance optimize intervals between corrective repairs, minimizing the number and cost of unscheduled repairs created by machine-train failures, improving the overall equipment reliability, and assisting the Asset Management Group with accurately determining an asset's RUL.

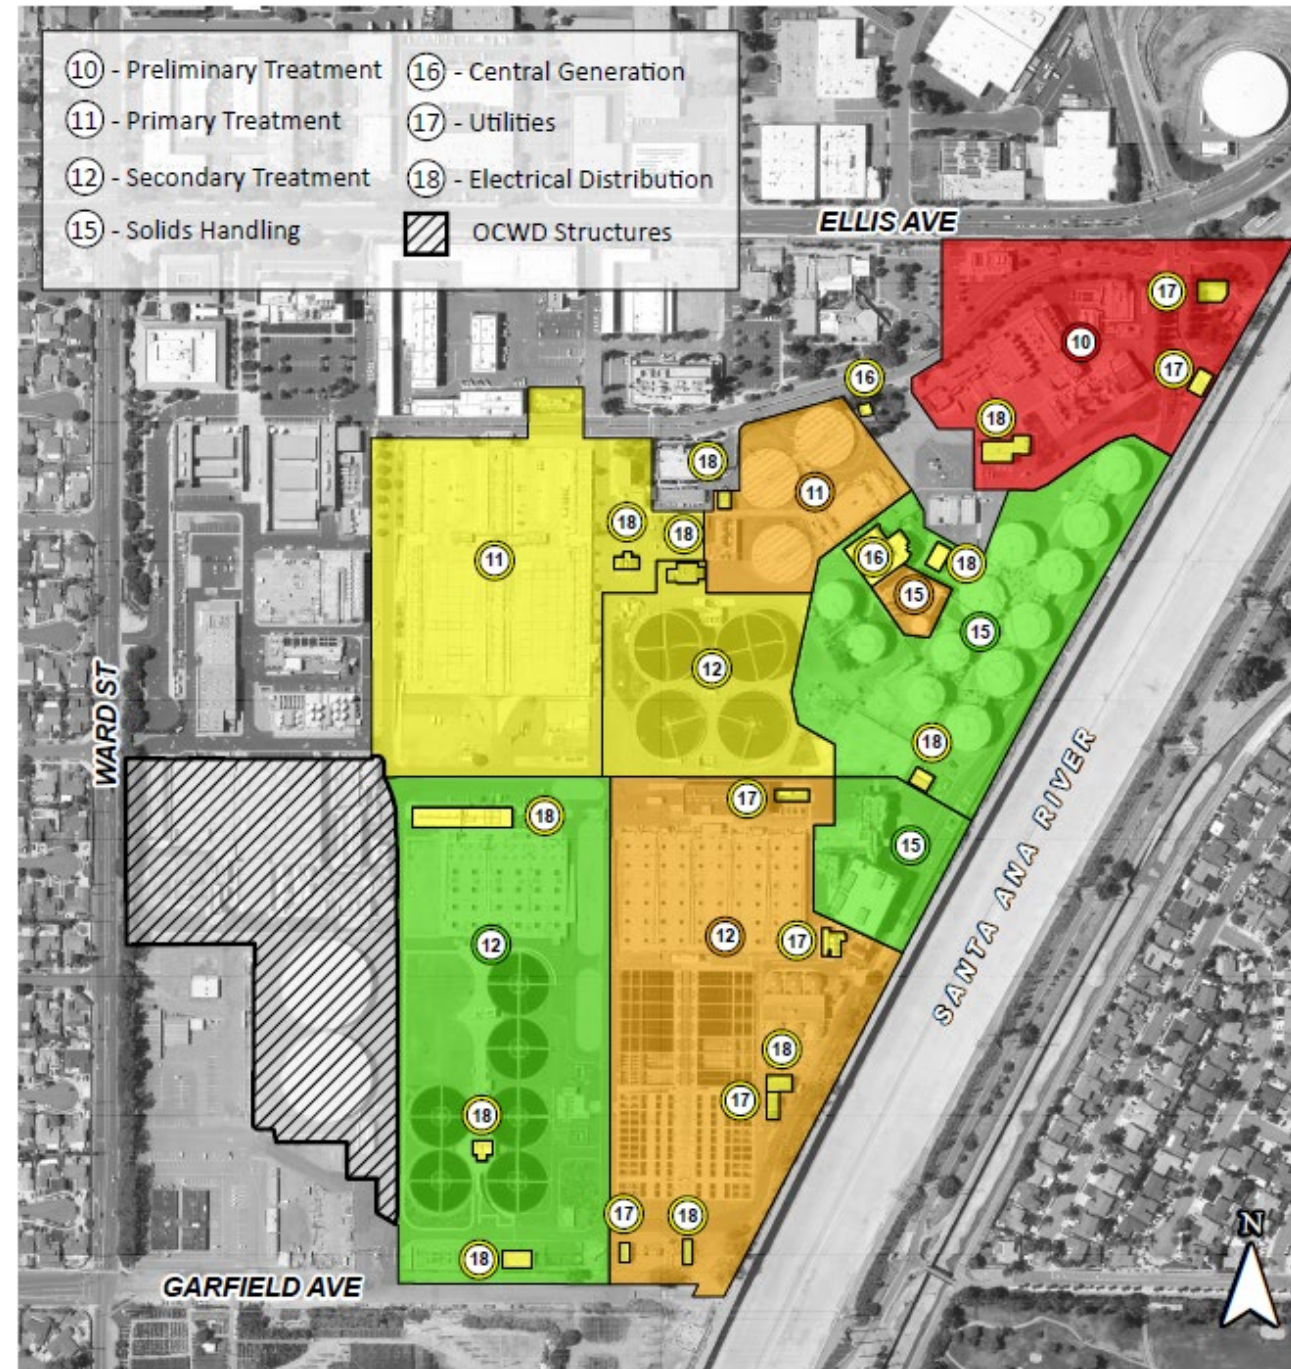
Figure 2-1. Plant No. 1 Process Area – Remaining Useful Life Score Map

The following system-level summaries provide a high-level overview of the Area AM Summaries contained in Section 2.2. The RUL scores are an average of the RUL scores for that discipline within that process area. Detailed condition scores are presented in the Area AM Summaries. The system-level summaries are organized by:

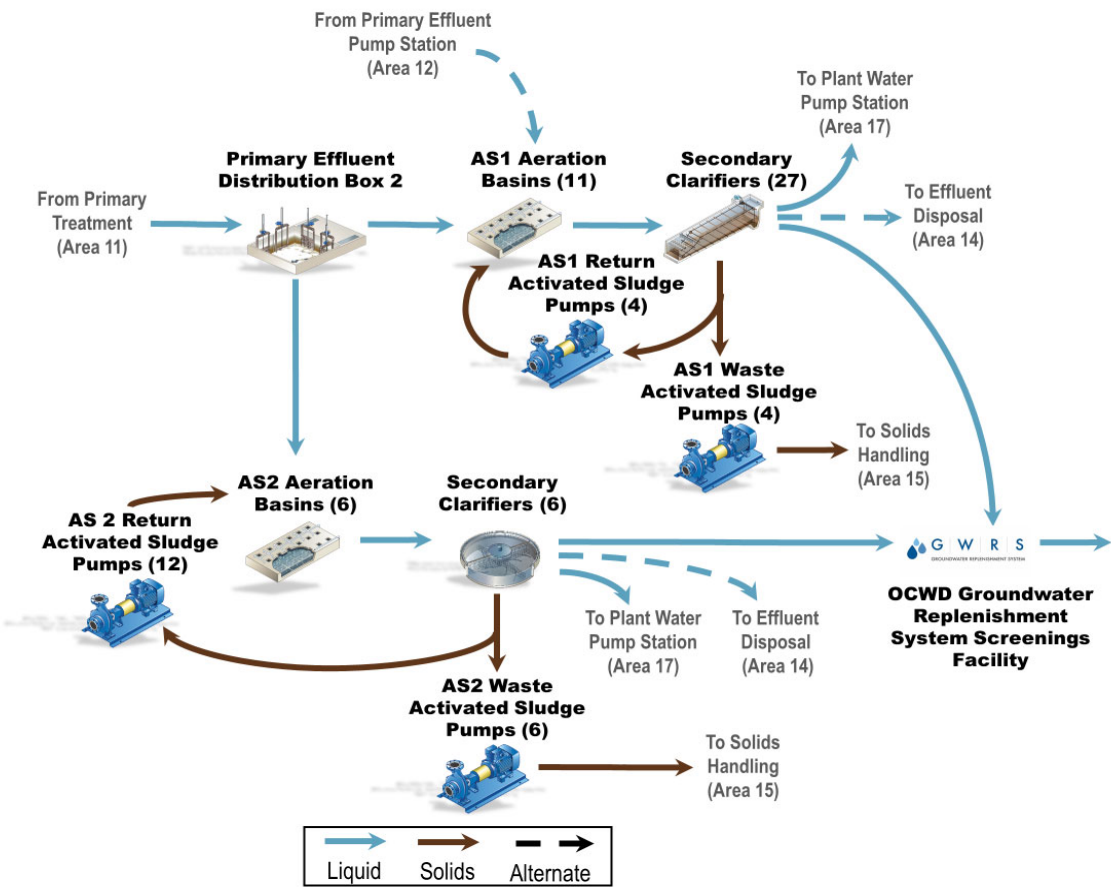
Process Schematic

ASSET MANAGEMENT SYSTEM SUMMARY – AREA 12 – PLANT NO. 1 SECONDARY TREATMENT – ACTIVATED SLUDGE

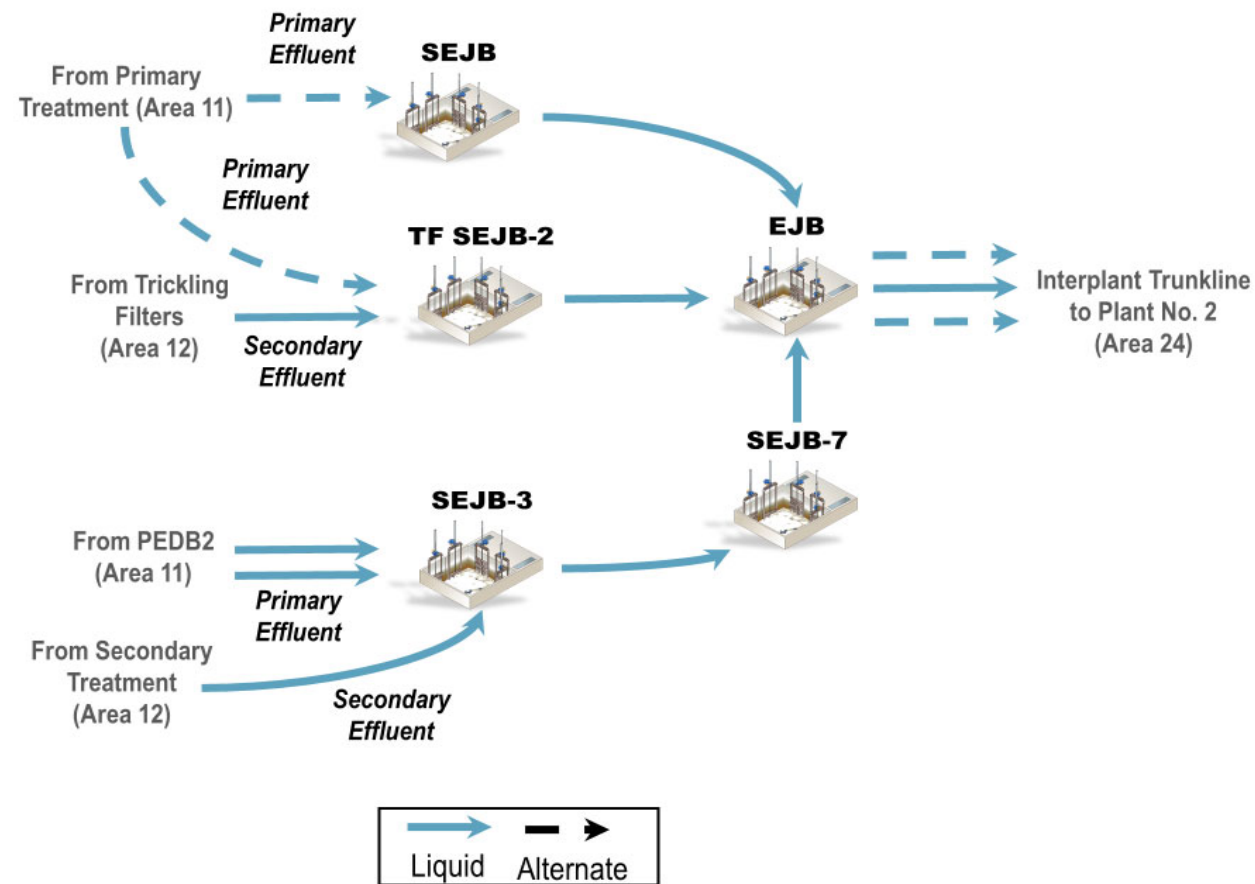
Process Schematic

ASSET MANAGEMENT SYSTEM SUMMARY – AREA 14 - PLANT NO. 1 INTERPLANT

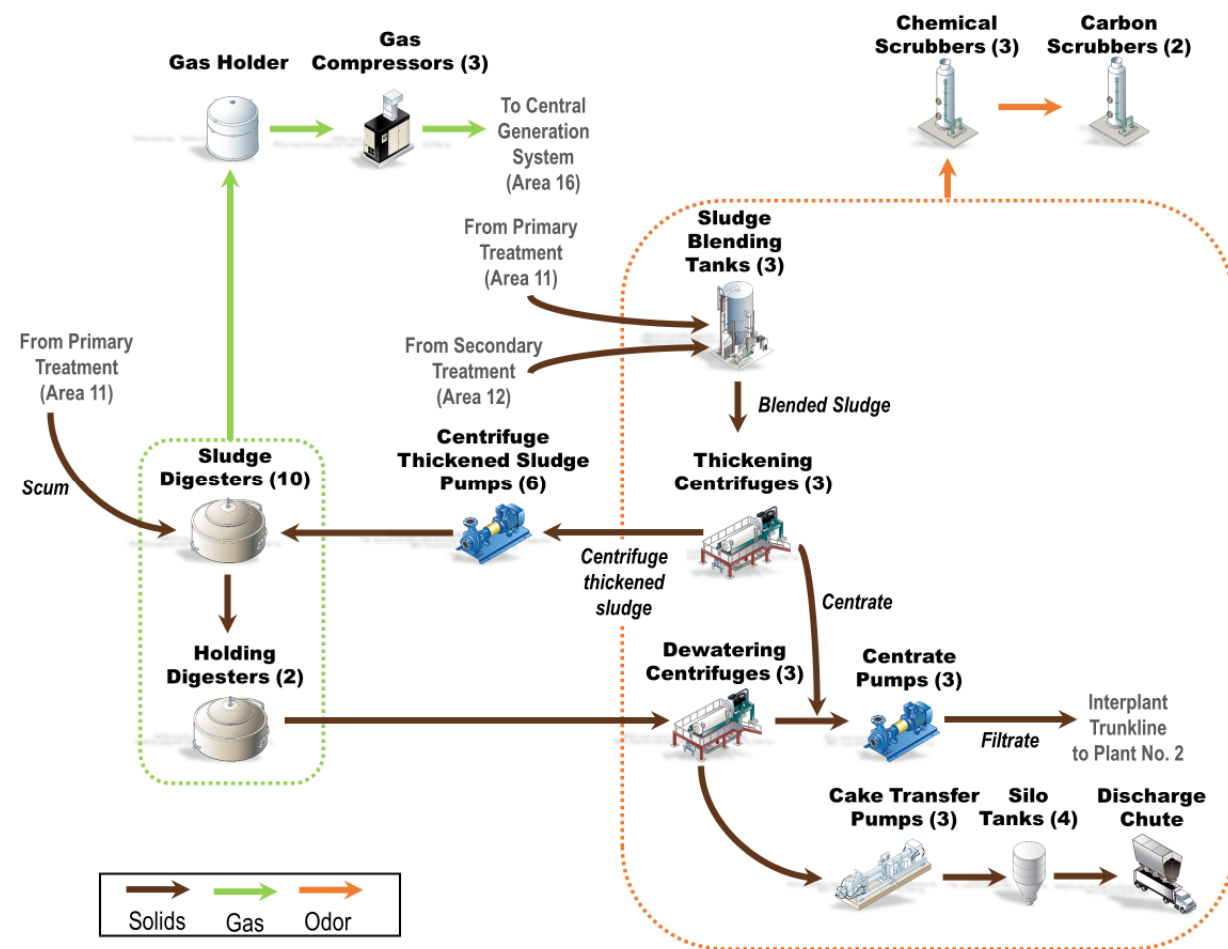
Process Schematic

ASSET MANAGEMENT SYSTEM SUMMARY – AREA 15 – PLANT NO. 1 SOLIDS HANDLING – FACILITIES

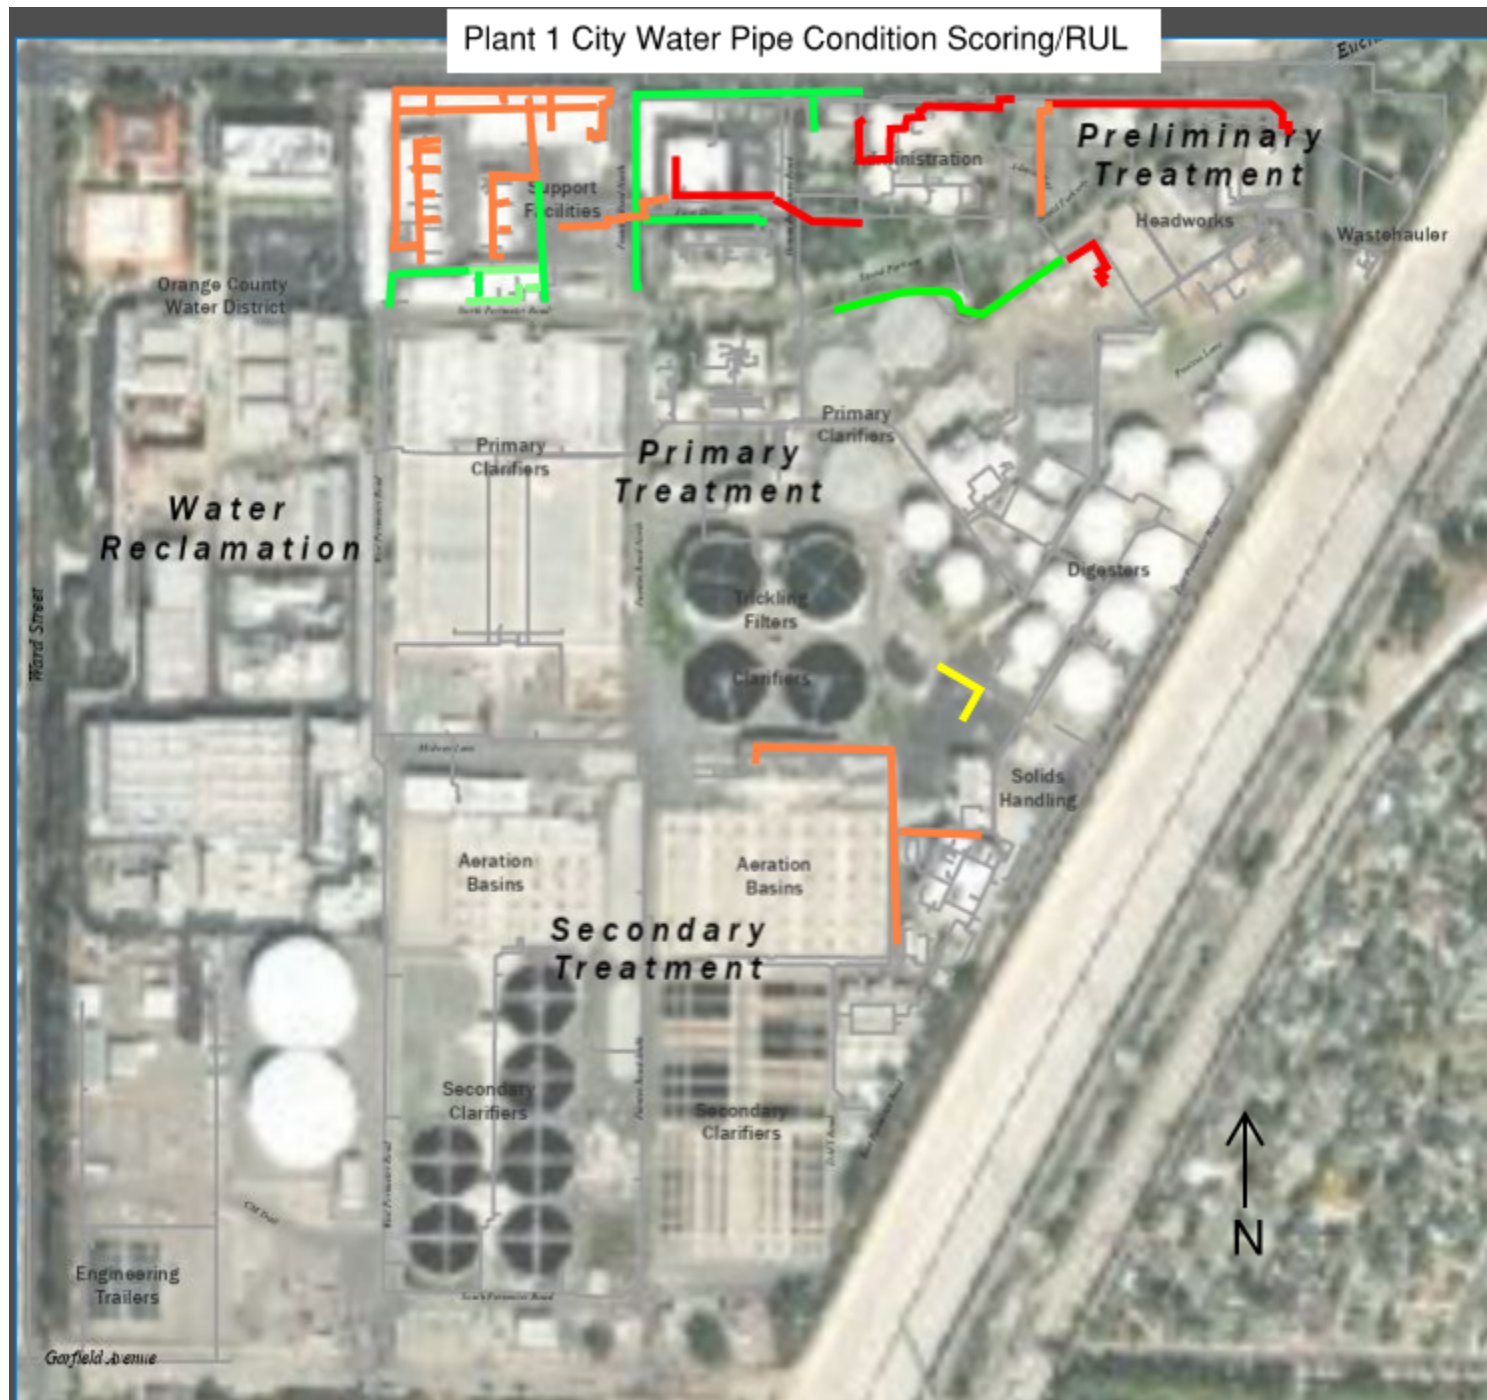
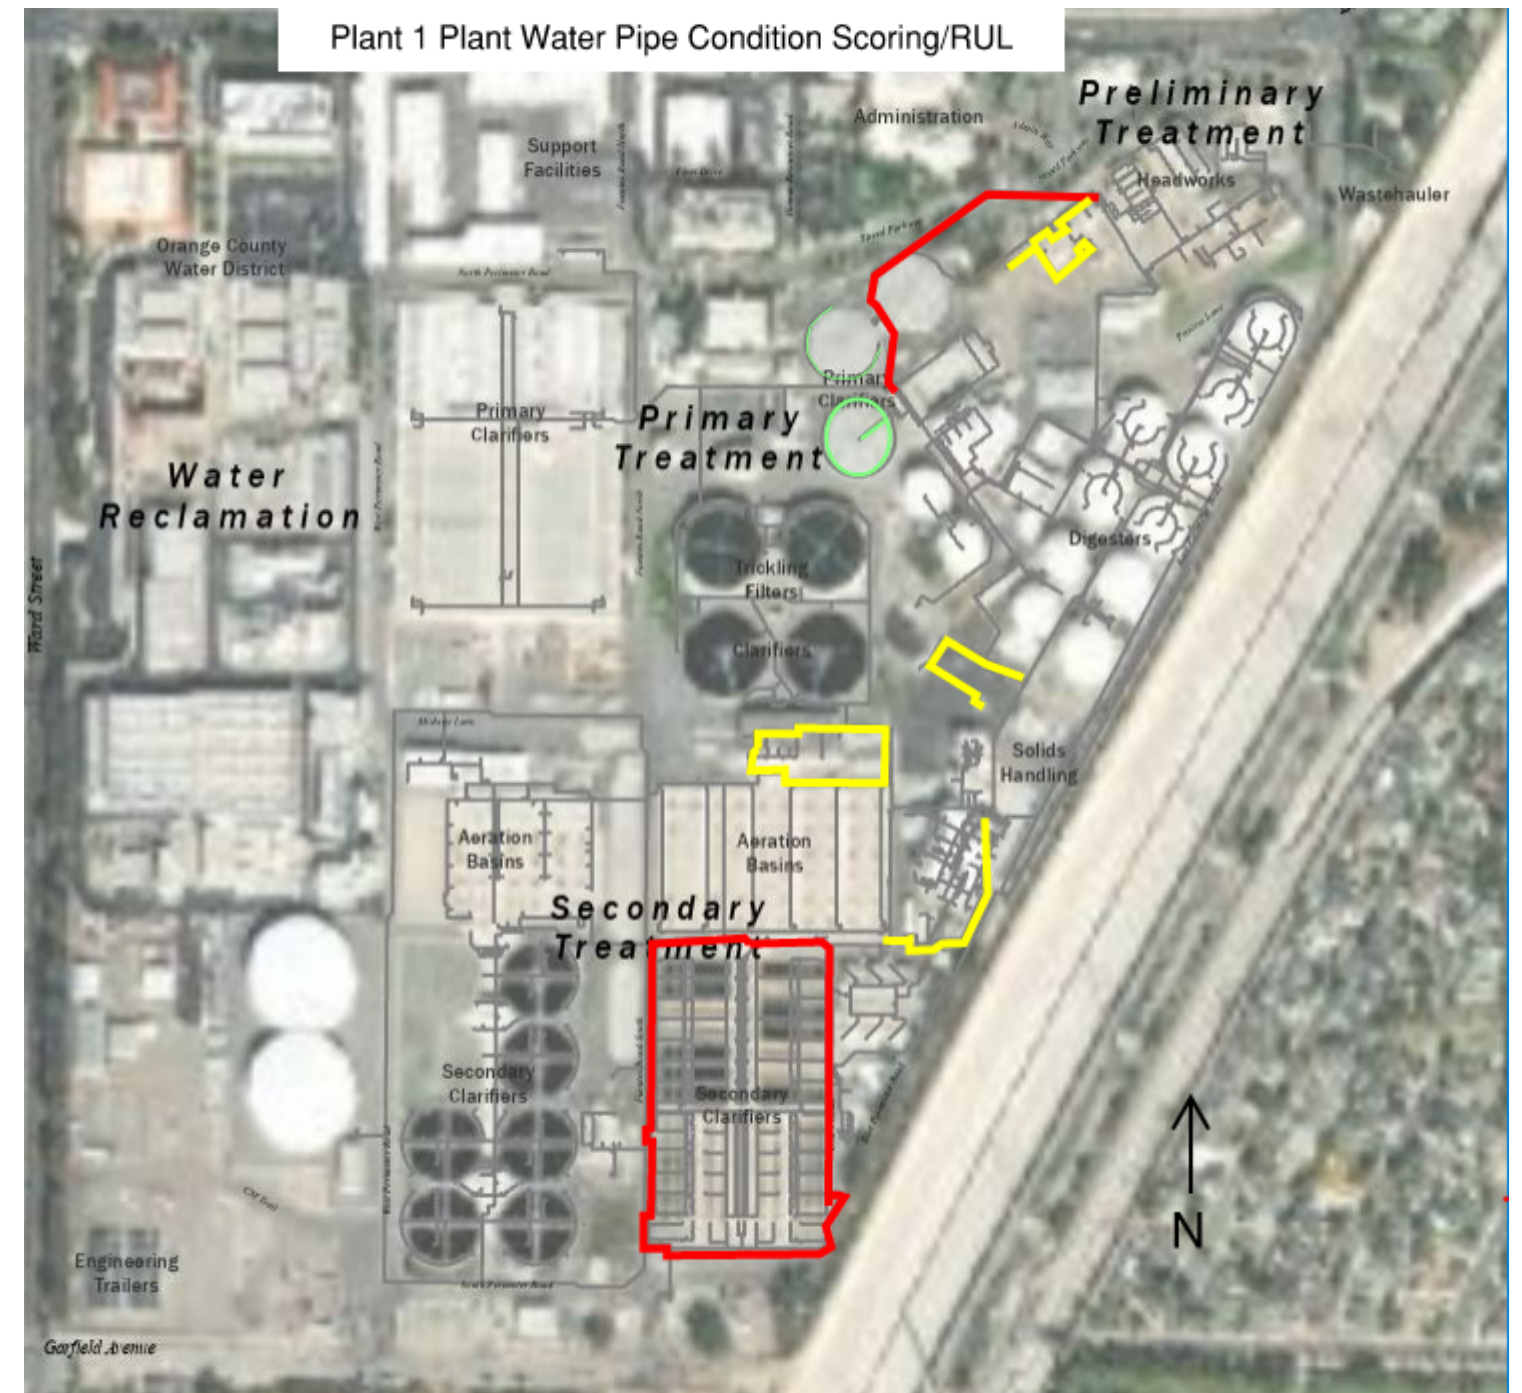
Remaining Useful Life of Utility Infrastructure

ASSET MANAGEMENT SYSTEM SUMMARY – AREA 17 – PLANT NO. 1 UTILITIES

| ■ RUL <5 years | ■ RUL 5-10 years | ■ RUL 11-15 years | ■ RUL 16-20 years | ■ RUL >20 years |

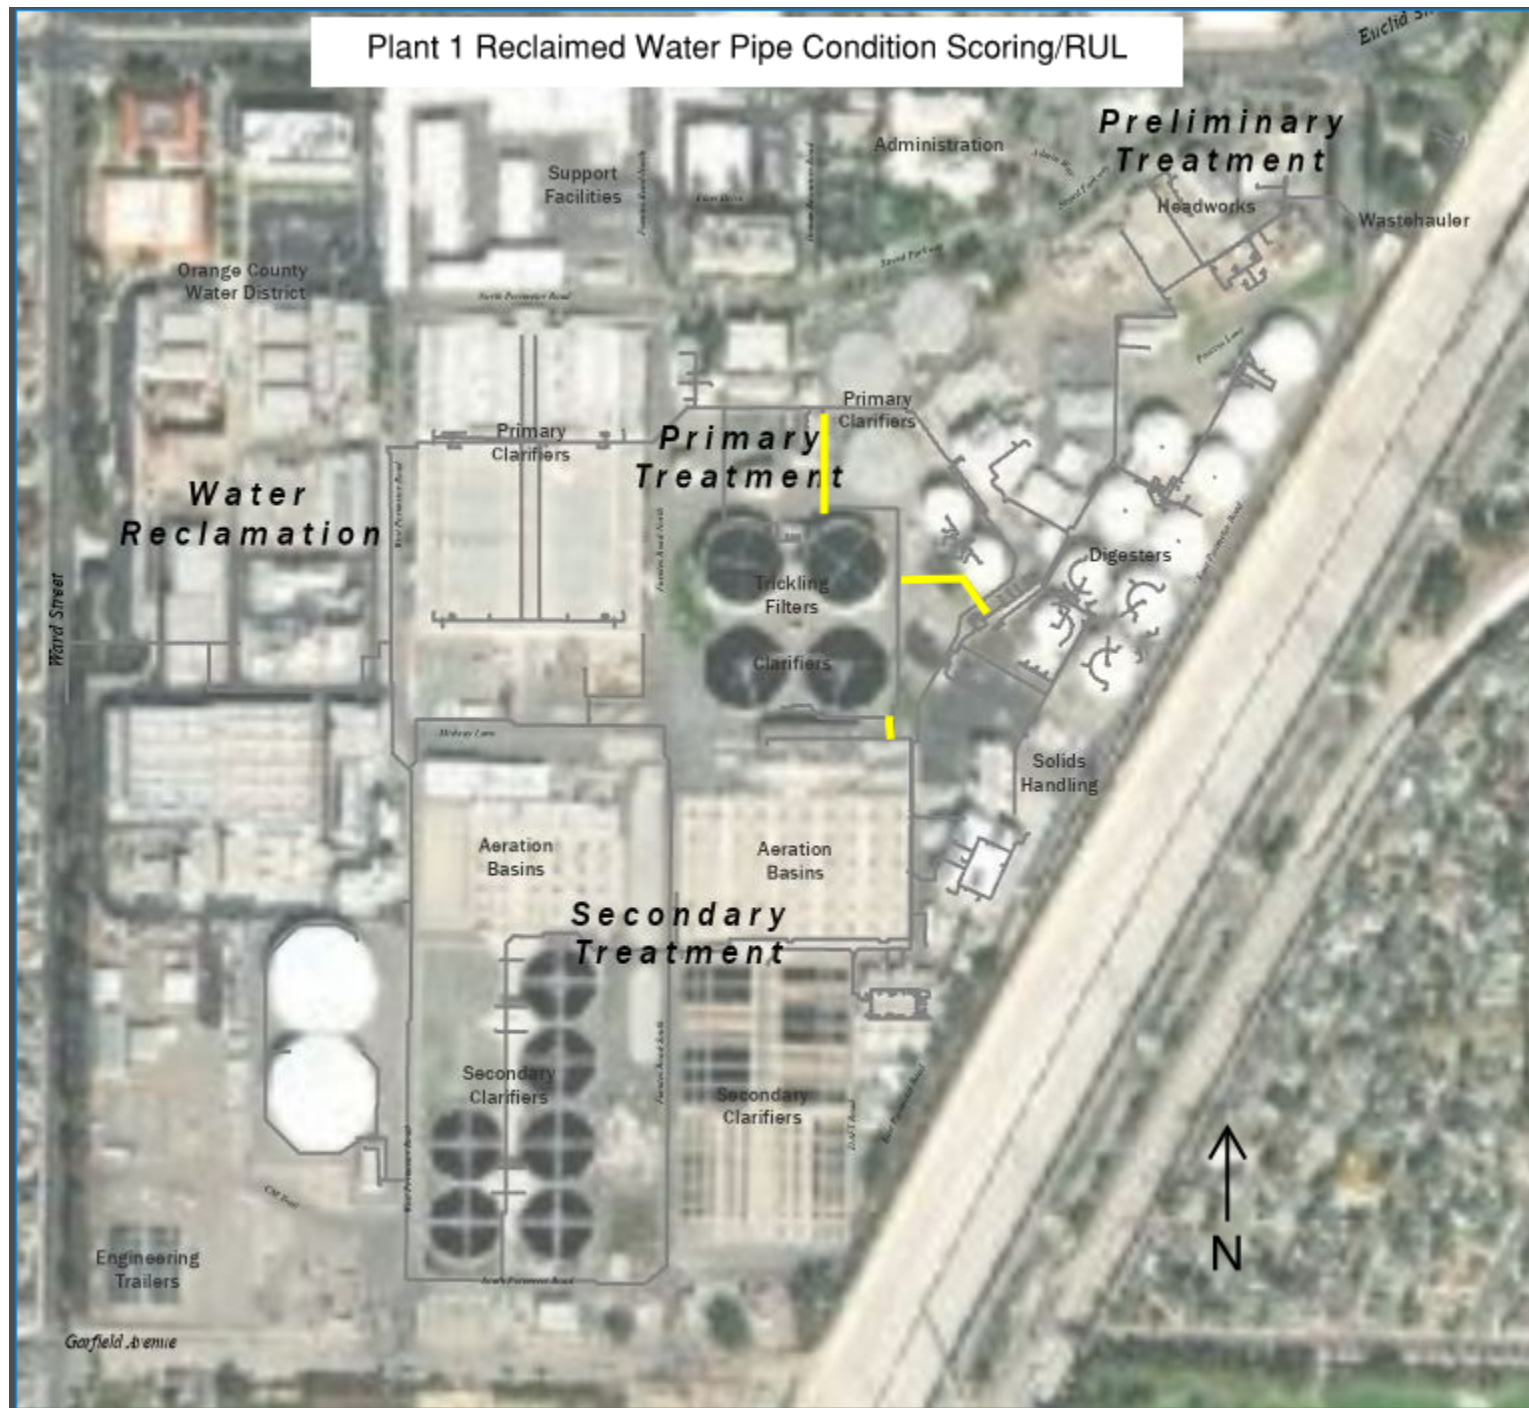
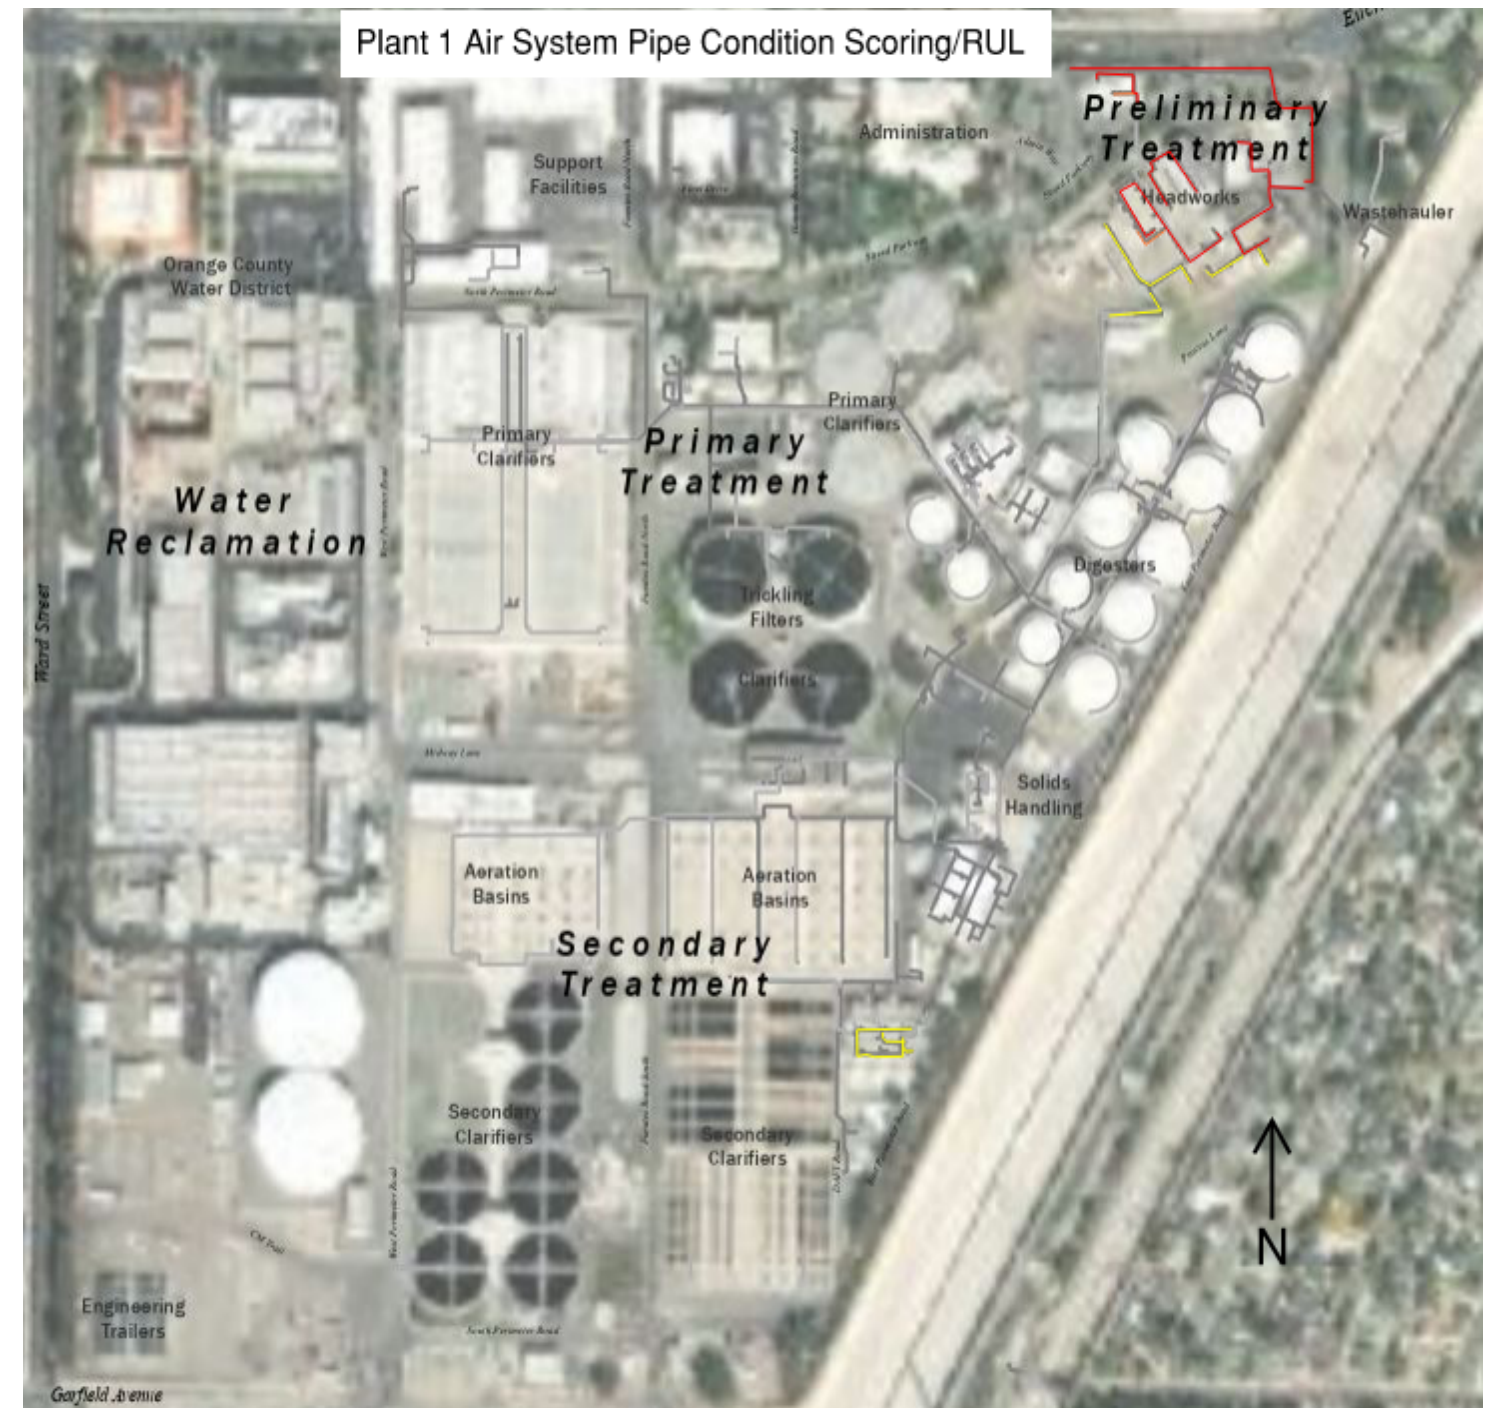
Remaining Useful Life of Utility Infrastructure

ASSET MANAGEMENT SYSTEM SUMMARY – AREA 17 – PLANT NO. 1 UTILITIES

| ■ RUL < 5 years | ■ RUL 5-10 years | ■ RUL 11-15 years | ■ RUL 16-20 years | ■ RUL > 20 years |

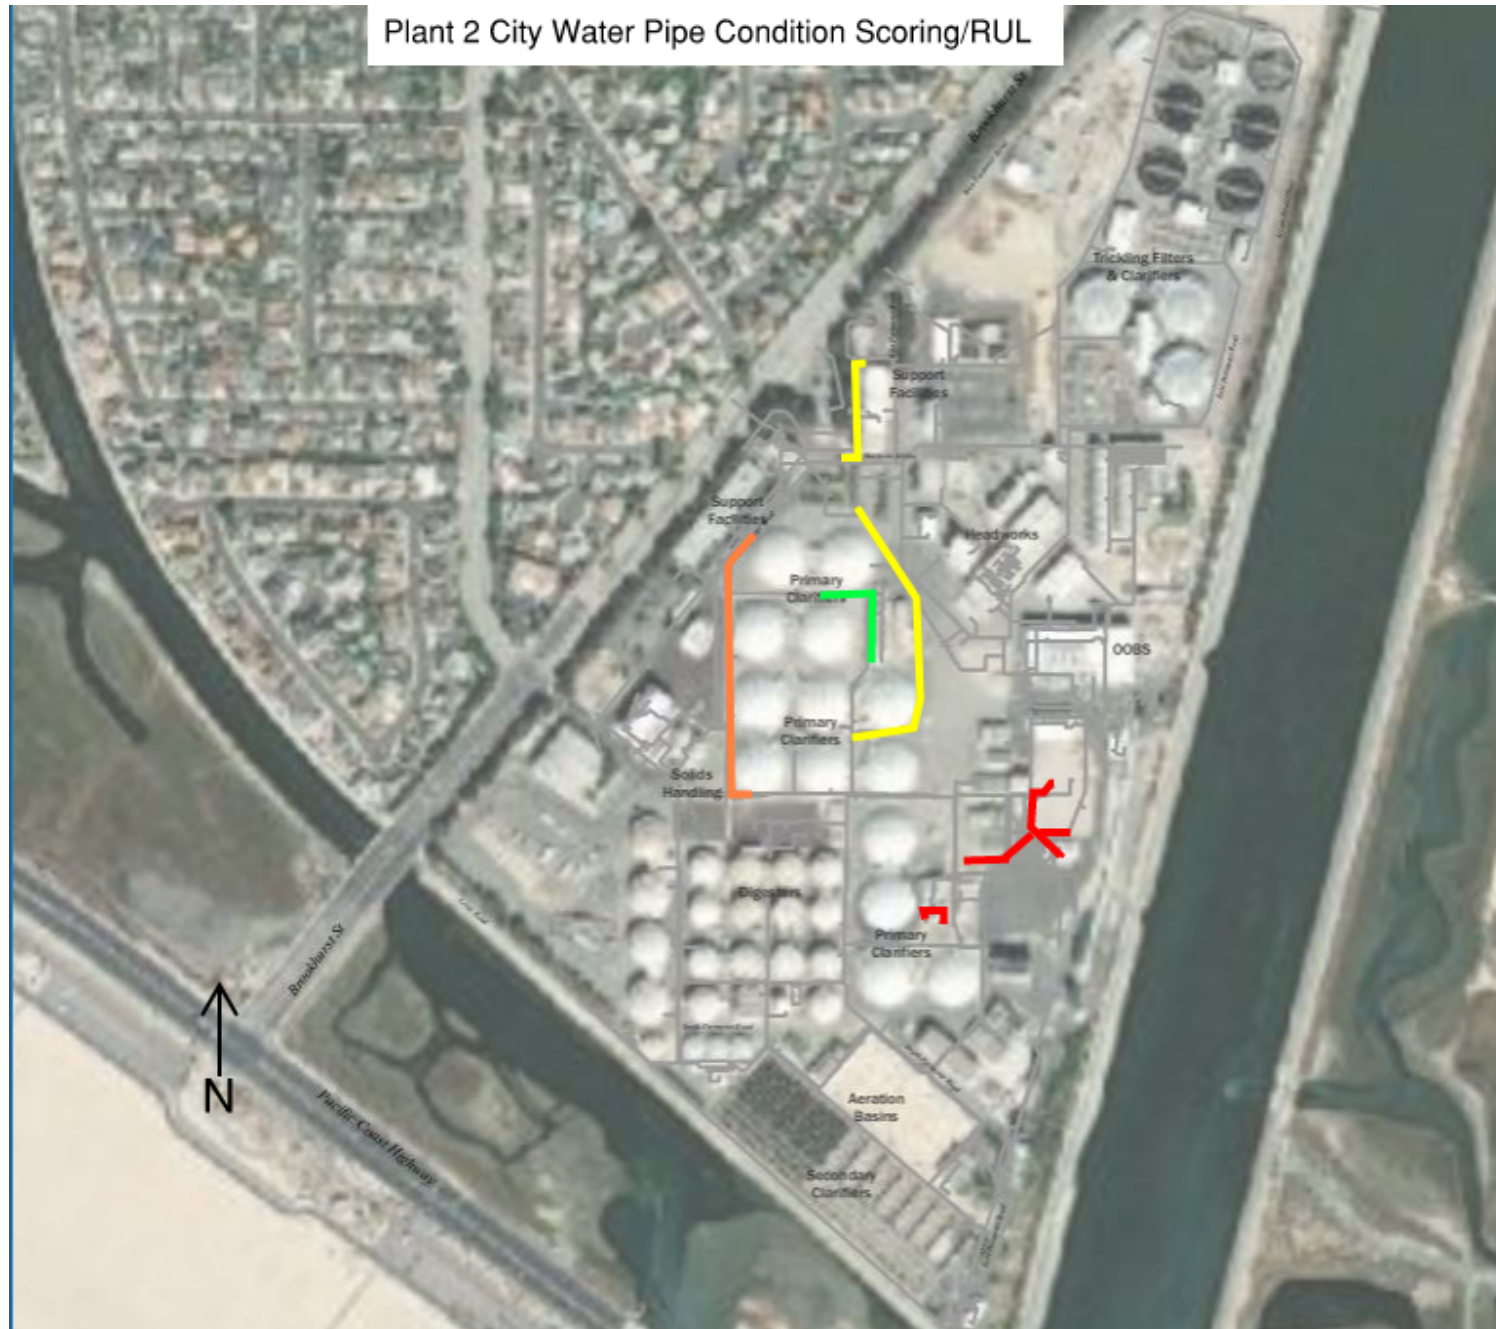
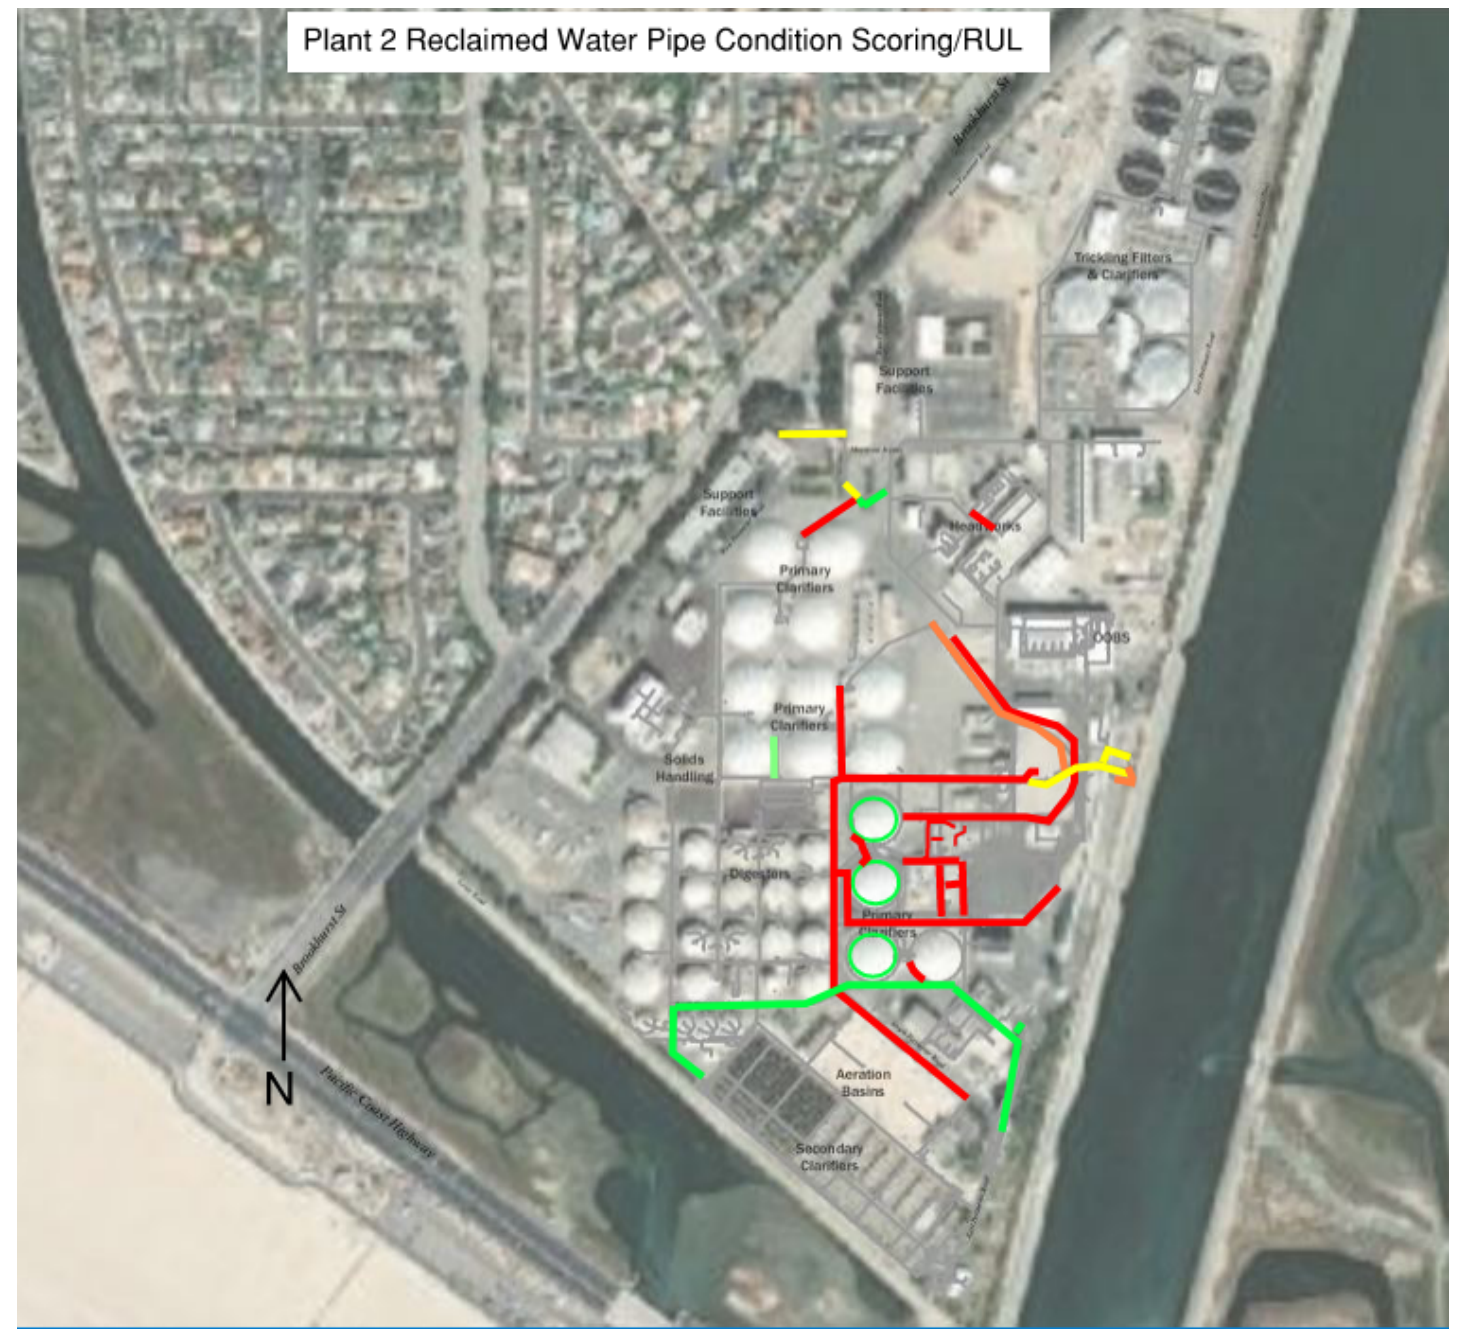
Remaining Useful Life of Utility Infrastructure

ASSET MANAGEMENT SYSTEM SUMMARY – AREA 27 – PLANT NO. 2 UTILITIES

| ■ RUL <5 years | ■ RUL 5-10 years | ■ RUL 11-15 years | ■ RUL 16-20 years | ■ RUL >20 years |
