ASSET MANAGEMENT PLAN

OC San owns and operates wastewater collection system infrastructure, as well as two resource recovery and wastewater treatment facilities, located in Fountain Valley and Huntington Beach. Our collection system infrastructure includes 388 miles of regional trunk sewer pipelines and 15 pump stations located throughout the OC San service area (Figure ES-1-1). Wastewater is conveyed to Reclamation Plant No. 1 in Fountain Valley and Treatment Plant No. 2 in Huntington Beach. These facilities treat an average daily wastewater flow of 180 million gallons per day (MGD), serving over 2.6 million people in central and northern Orange County, California.

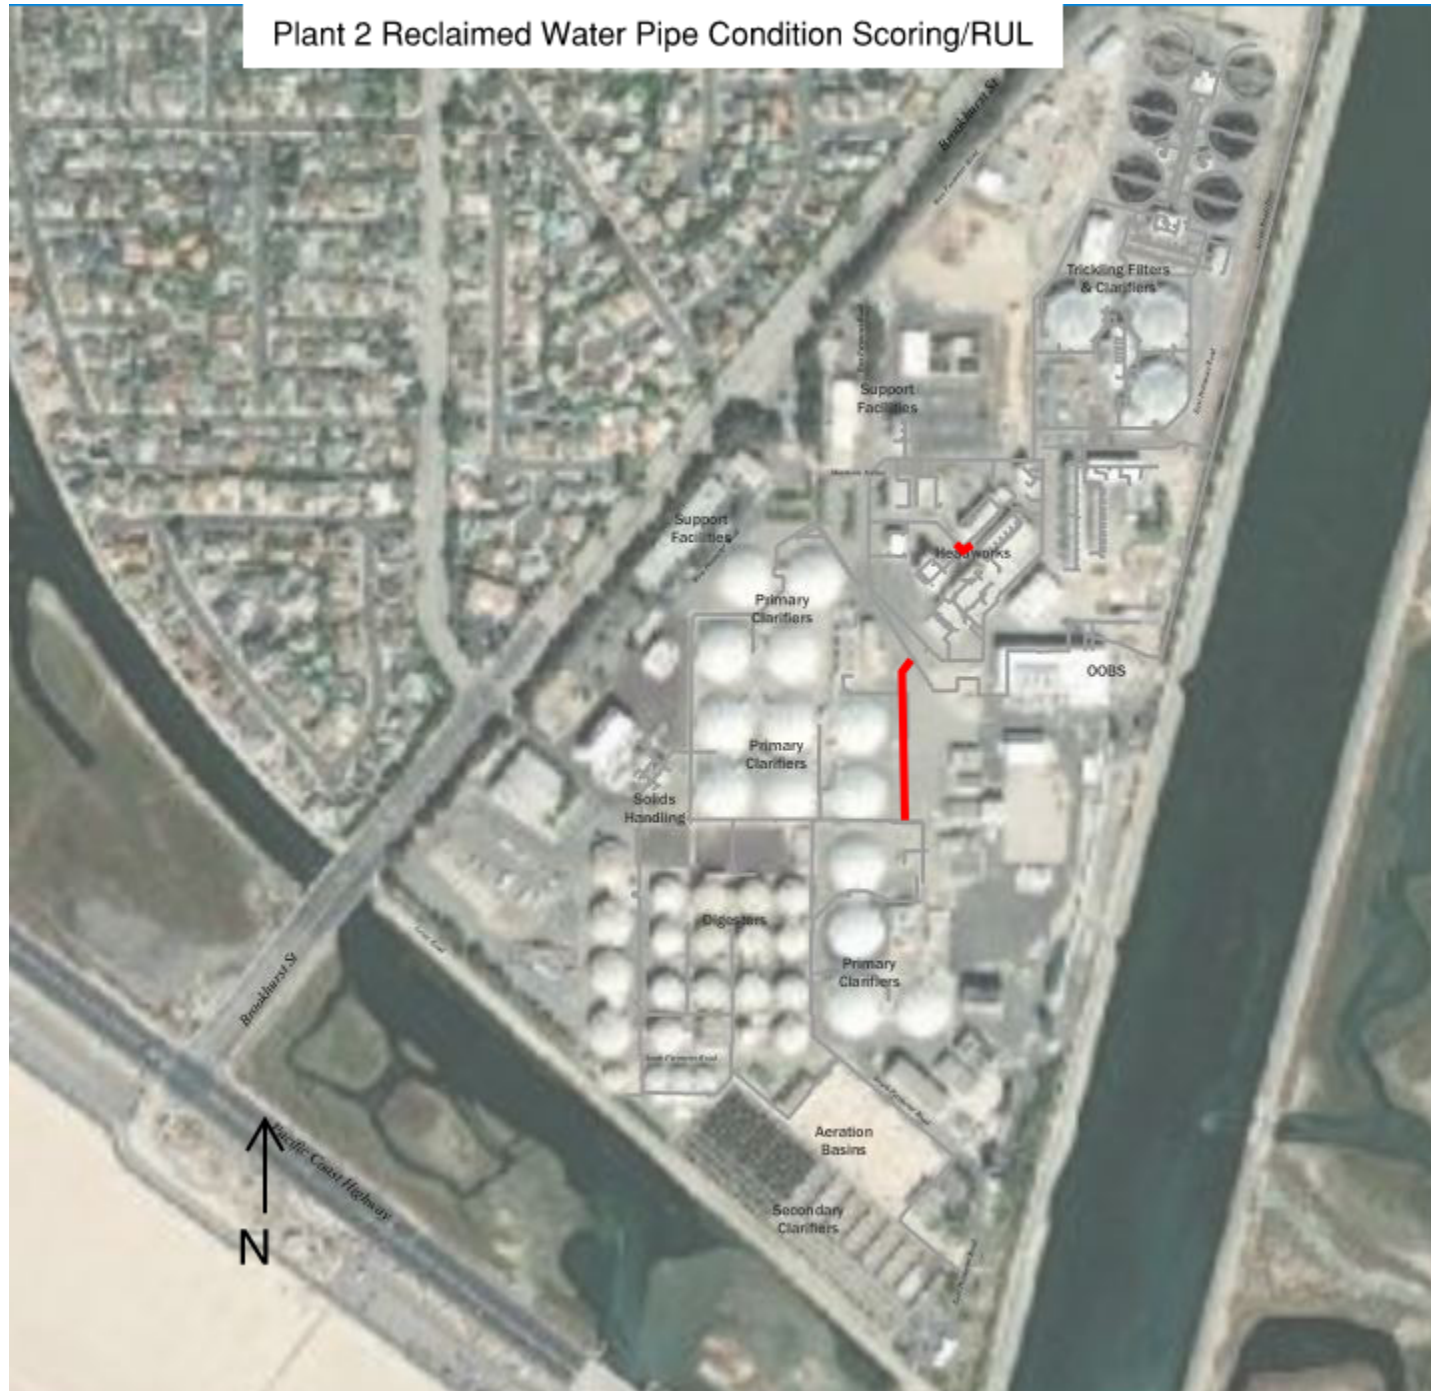
Remaining Useful Life of Utility Infrastructure

ASSET MANAGEMENT SYSTEM SUMMARY – AREA 27 – PLANT NO. 2 UTILITIES

| ■ RUL <5 years | ■ RUL 5-10 years | ■ RUL 11-15 years | ■ RUL 16-20 years | ■ RUL >20 years |

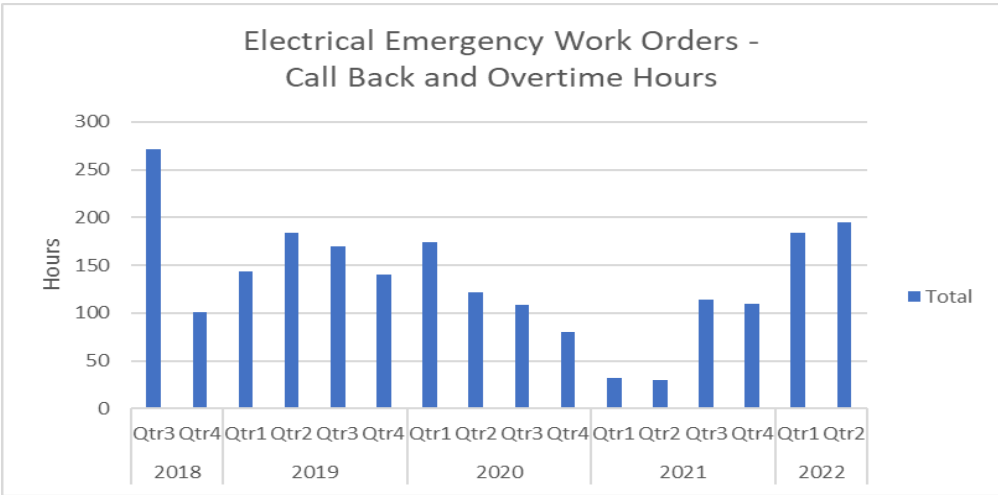
Figure 3-1. Electrical Emergency Work Orders

The trend in emergency call out work for Electrical and Mechanical assets shown in Figures 3-1 and 3-2, respectively and reflects the demand older assets can have to maintain reliability of a facility.

The number of electrical “emergency” work orders and associated hours increased primarily due to electrical outages at the pump stations. The mechanical emergency work increased primarily due to work at the Plant 1 Sunflower pumps, waste side stream pump station and the gas compressors. All three areas have future projects that will rehabilitate or replace the equipment. We expect the trend for Electrical break-in/emergency work to trend down as more electrical projects are implemented to replace or upgrade aging assets. Overall, mechanical break-in/emergency work continues to trend down over time which is a good indicator on the effectiveness of the Asset Management Program.

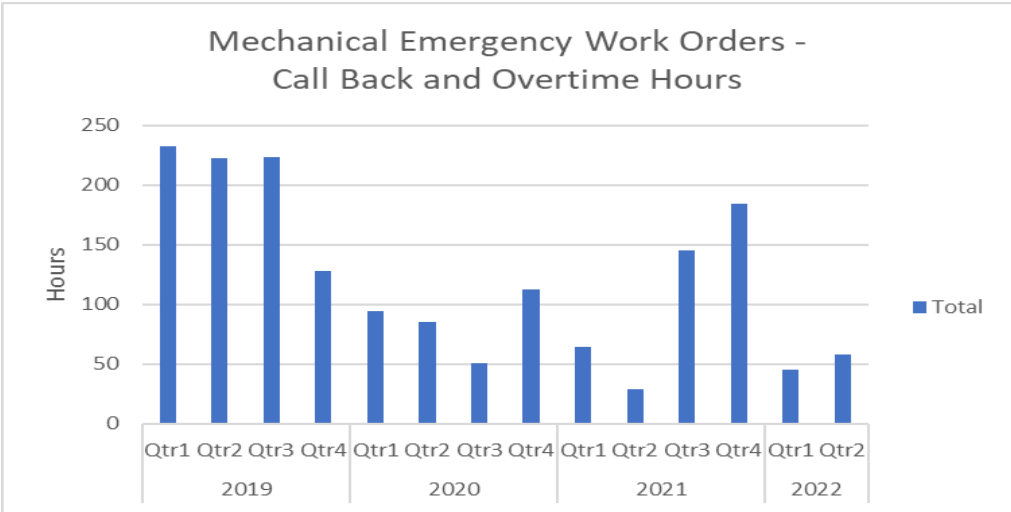
Figure 3-2. Mechanical Emergency Work Orders

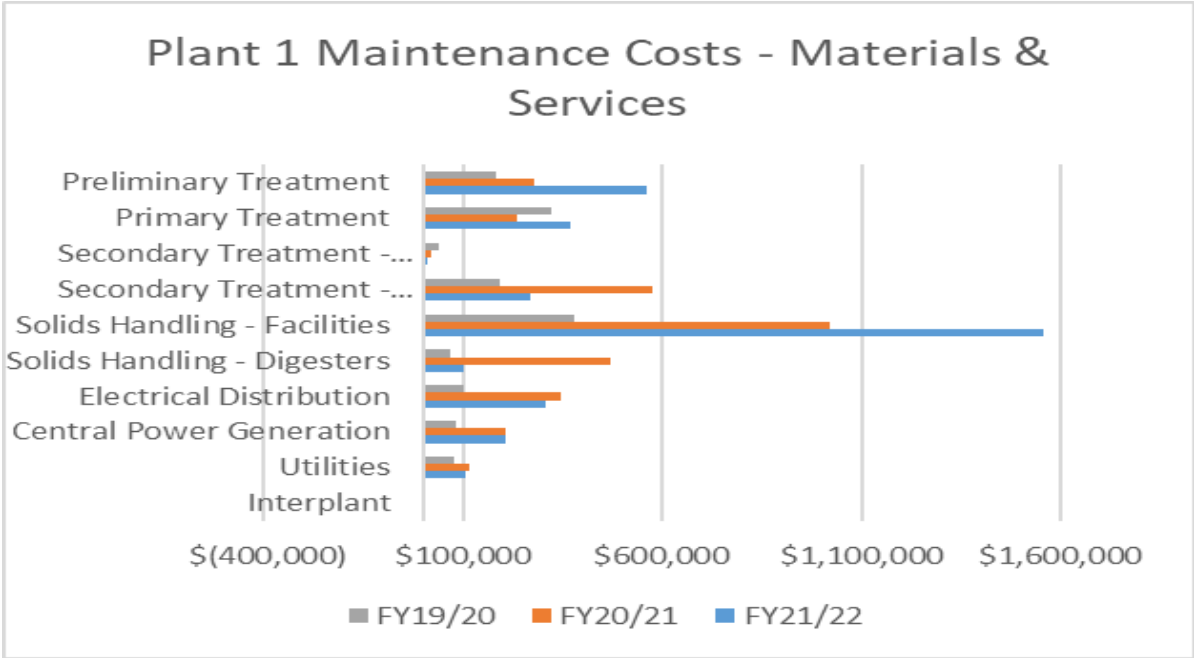
Figure 3-3. Graph of Maintenance Costs (Materials and Services) at Plant No. 1

OC San uses the maintenance costs and number of labor hours over time as trend indicators to indicate the amount of resources devoted to reliably maintaining the process areas. Figure 3-3 shows Maintenance costs (materials and services) per FY broken down by process area at Plant 1. The data indicates that there has been a large increase in maintenance costs at

Plant No. 1 Solids Handling due to high cost to maintain the new dewatering equipment and contracts with manufactures of the equipment.

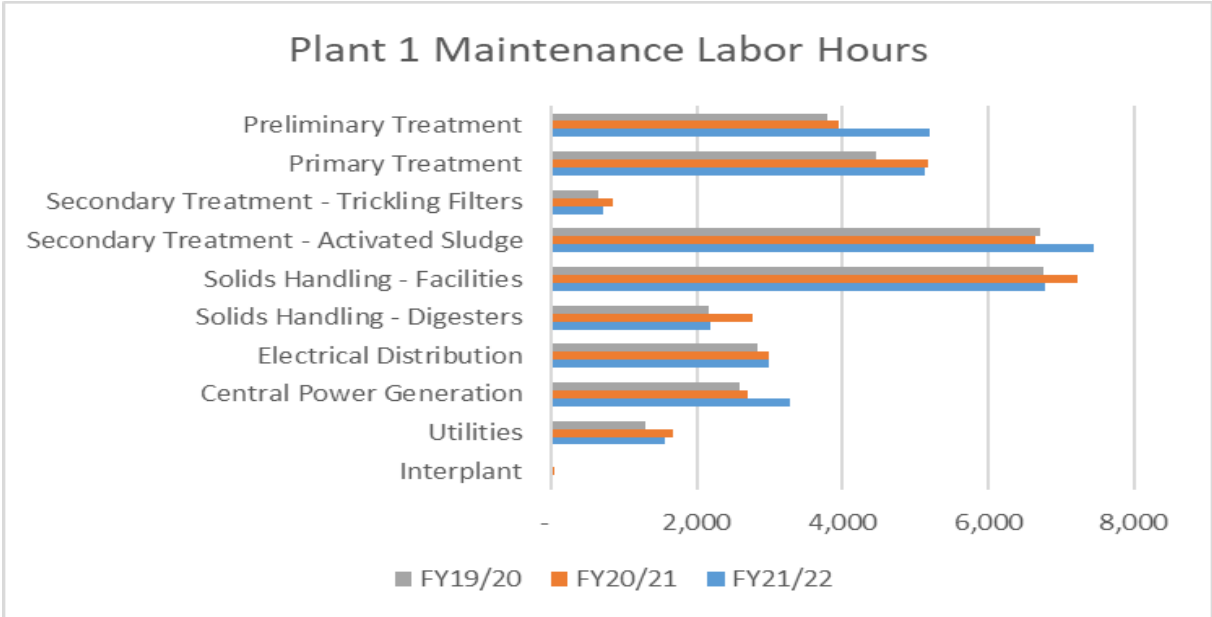
Figure 3-4. Graph of Maintenance Labor Hours at Plant No. 1

Figure 3-4 shows Maintenance labor hours per FY broken down by process area at Plant 1. The labor hours are high at the Plant No.1 secondary facility because of the older equipment at activated sludge facility 1 which is scheduled for rehabilitation under project P1-140. The labor hours are also high at the solids handling facility because the new thickening and dewatering process has more complex equipment that requires more staff to operate and maintain.

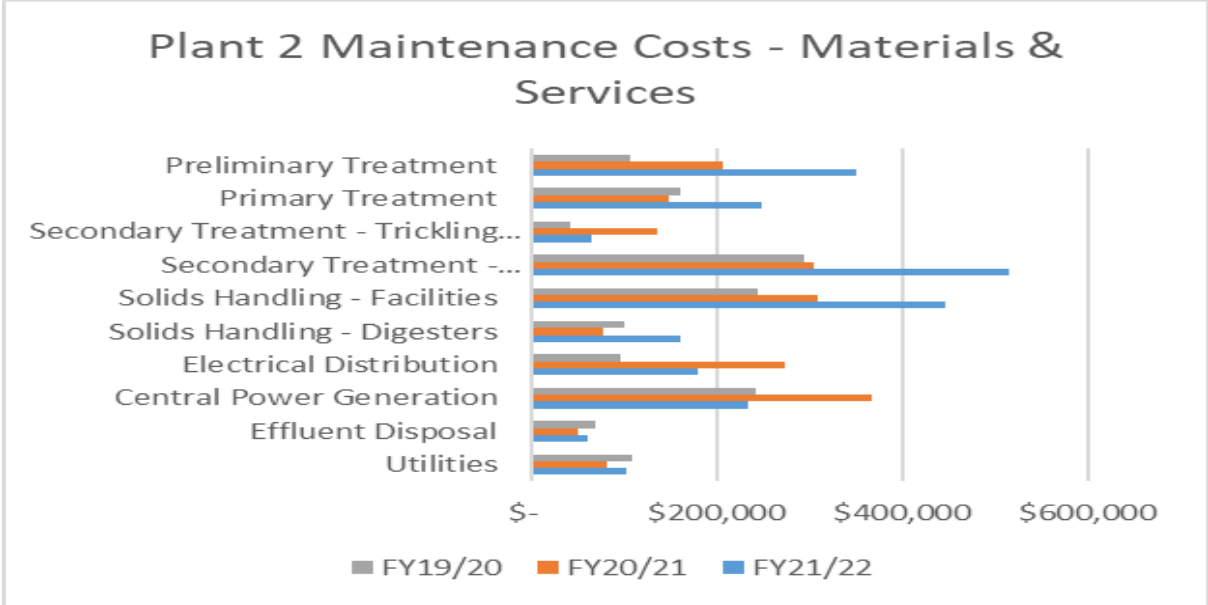
Figure 3-5. Graph of Maintenance Costs (Materials and Services) at Plant No. 2

Figure 3-5 shows Maintenance costs (materials and services) per FY broken down by process area at Plant 2. The maintenance cost at Plant No. 2 were higher for FY21/22 for the secondary treatment process because of the oxygen pipe repairs due to accelerated corrosion. It is also higher for solids handling because of the complex dewatering and odor control equipment illustrated on Figure 3-5. Figure 3-6 shows Maintenance labor hours per FY broken down by process area at Plant 2.

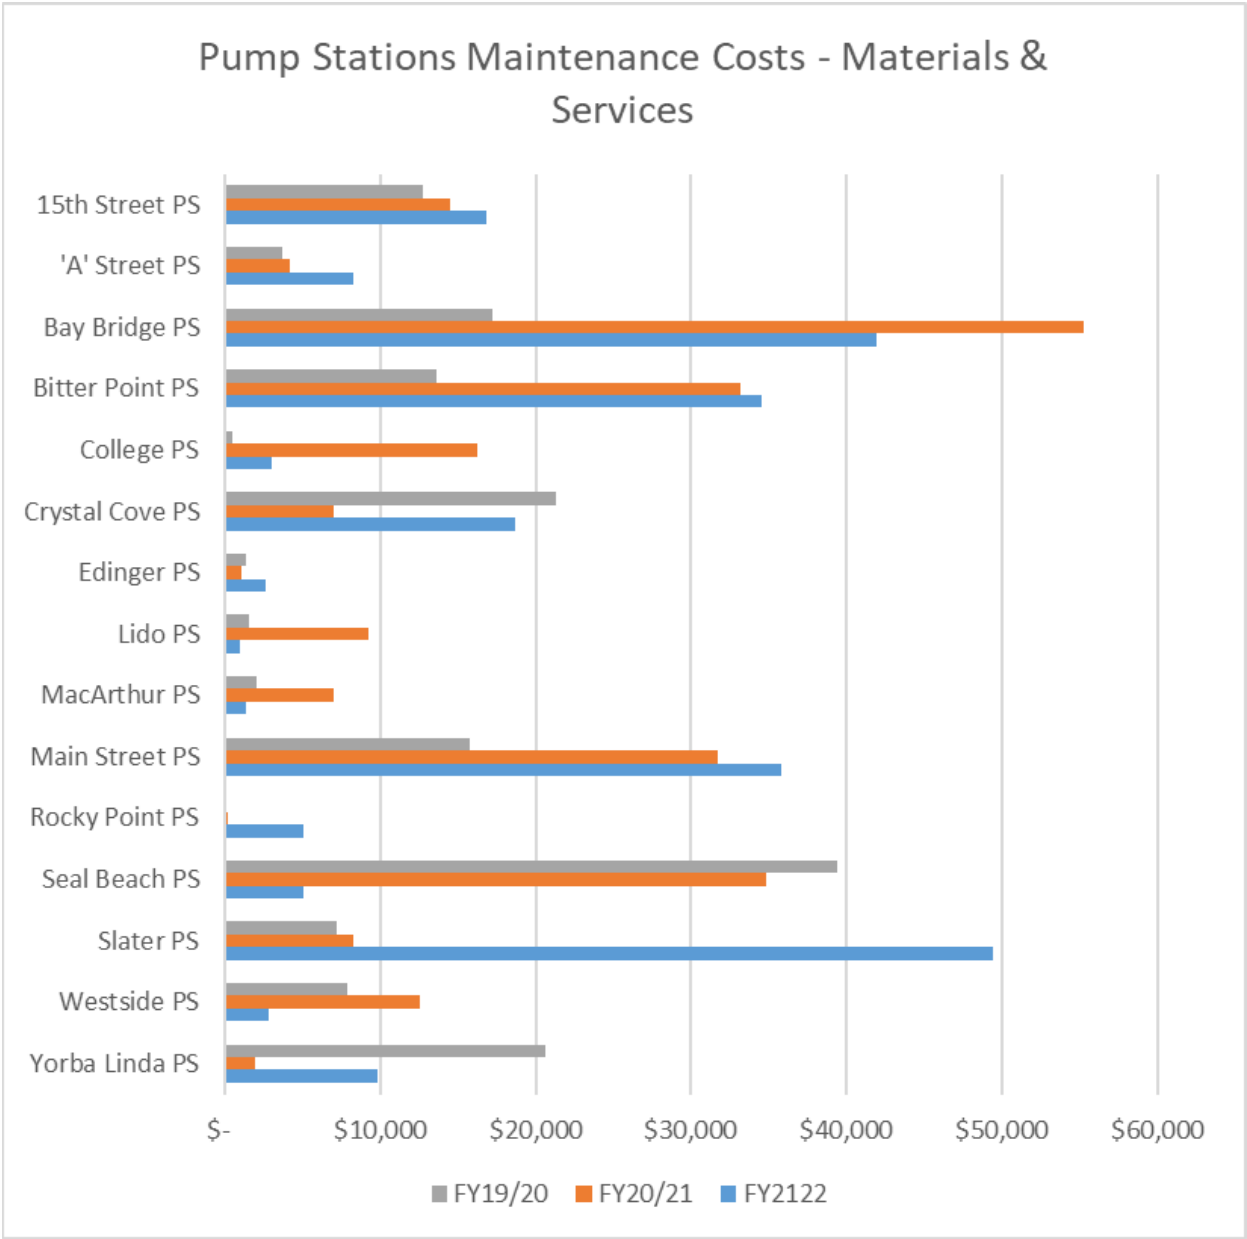
Figure 3-7. Graph of Pump Station Maintenance Costs (Materials and Services)

Maintenance labor hours and costs for the pump stations are included below in Figure 3-7 and Figure 3-8 below. There is a large increase in maintenance costs at the Slater Pump Station due to aging pumps requiring repair and rebuilding. This was also noticed with the increase in labor hours, break-in percent and decrease in the proactive percentage. Another large increase as compared to the previous year is at Crystal Cove pump station where both pumps had volute replacement due to corrosion/erosion. There is also an increase in labor hours at Seal Beach pump station due to the needs for staff to support current construction projects at the pump station.

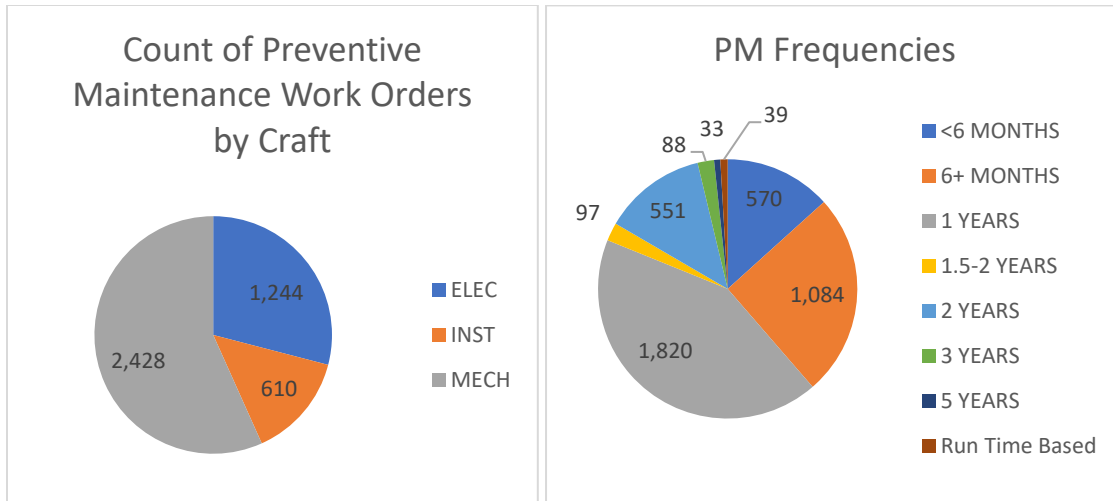
Figure 3-9. PM Workorder Broken Down by Both Craft and Frequency

OC San uses Maximo® as the computerized maintenance management system. All maintenance related activities are stored in Maximo®. In short, the information in Maximo® makes up OC San's Maintenance Plan. Maintenance planning primarily consists of PM and PdM work orders. Currently, OC San proactively maintains over 67,000 stored in Maximo®. For the assets associated with process and treatment, there are typically approximately 4,300 active PM work orders and on average 230 of those PMs are related to predictive maintenance activities. A summary and breakdown of the PMs and PdMs are shown on Figure 3-9.

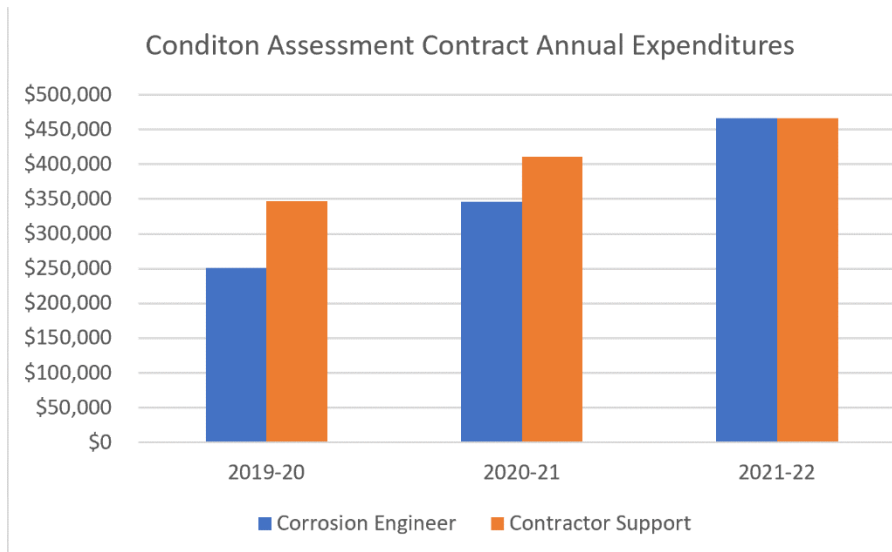
Figure 3-10. Condition Assessment Contract Expenditures

Corrosion condition assessments are a key component of the Asset Management Program by providing vital information with respect to the condition and life expectancy of critical plant and collections process structures and equipment. Condition assessments are conducted during scheduled maintenance activities, by staff observations of the condition of an asset or when necessary to determine a more accurate RUL. The Asset Management Team has completed approximately 50 different condition assessments last fiscal year spending just under \$1 million utilizing an outside consultant and contractor. Figure 3.10 provides annual expenditures on the two condition assessment contracts for the last three fiscal years. The 2019/20 expenditures were less because of the pandemic. The expenditures were higher in FY21/22 because more assessments were completed, the cost of incidental repairs on some digesters, and labor cost increases.

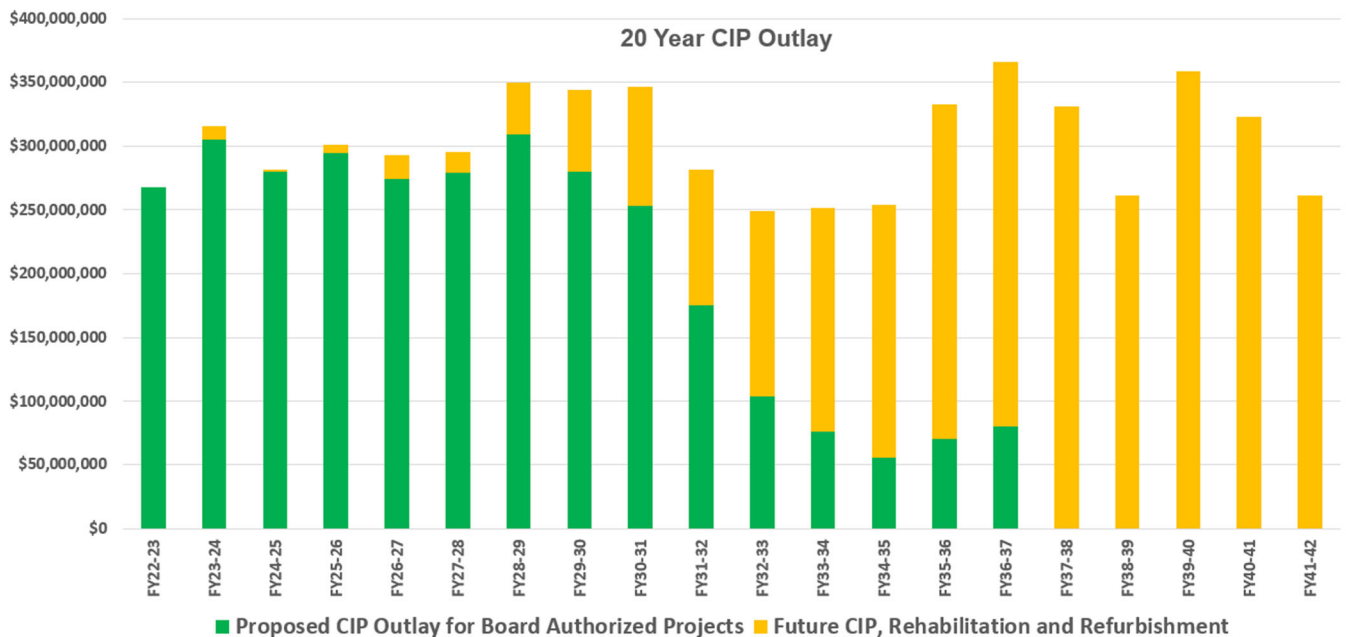
Figure 4-1. 20-Year CIP Outlay

FY22-23 Budget Update, the first year of the 2-year budget adopted in June 2022, includes updates to the 20-year CIP outlay. Figure 4-1 shows the 20-year CIP outlay, which includes current and projected future CIP projects. FY22-23 CIP Outlay is \$284.6 million and is further divided into process categories shown on Figure 4-2. From the chart, it is apparent that liquid treatment, support facilities, and collection facilities are primary areas where the FY 2022-23 CIP Outlay will be spent.

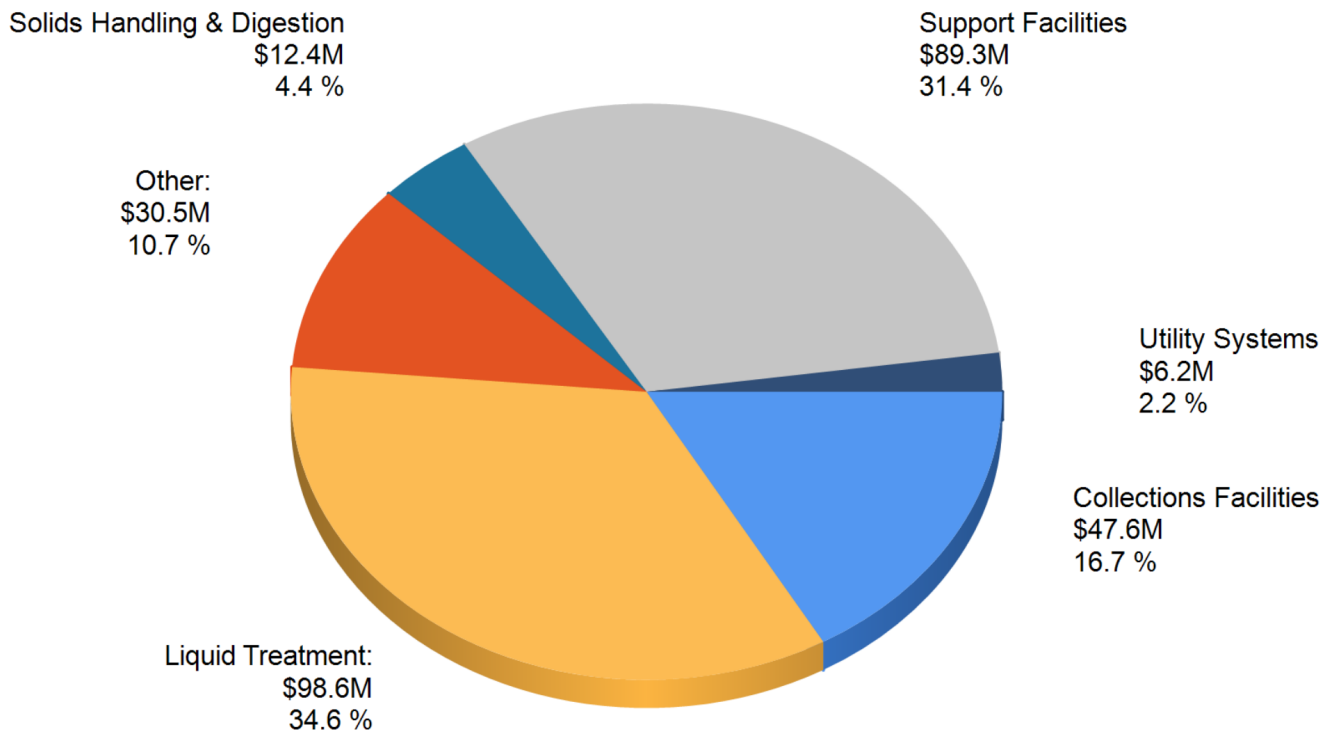
**Figure 4-2. FY22-23 CIP Outlay by Process – \$284.6 Million**

For liquid treatment, Project No. P1-105 Headworks Rehabilitation at Plant No. 1 and Project No. P2-98 Primary Treatment Rehabilitation Project are expected to be the largest expenditures of \$35 million and \$30.5 million, respectively, in FY 2022-23. For support facilities, Project No. P1-128 Headquarters Complex is the biggest driver with \$61 million in FY 2022-23. Lastly, for collection facilities, Project No. 3-64 Rehab of Western Regional Sewers and Project No. 7-65 Gisler-Red Hill Interceptor & Baker Force Main Rehab take more than half of collections CIP spending of \$17 million and \$10 million, respectively.

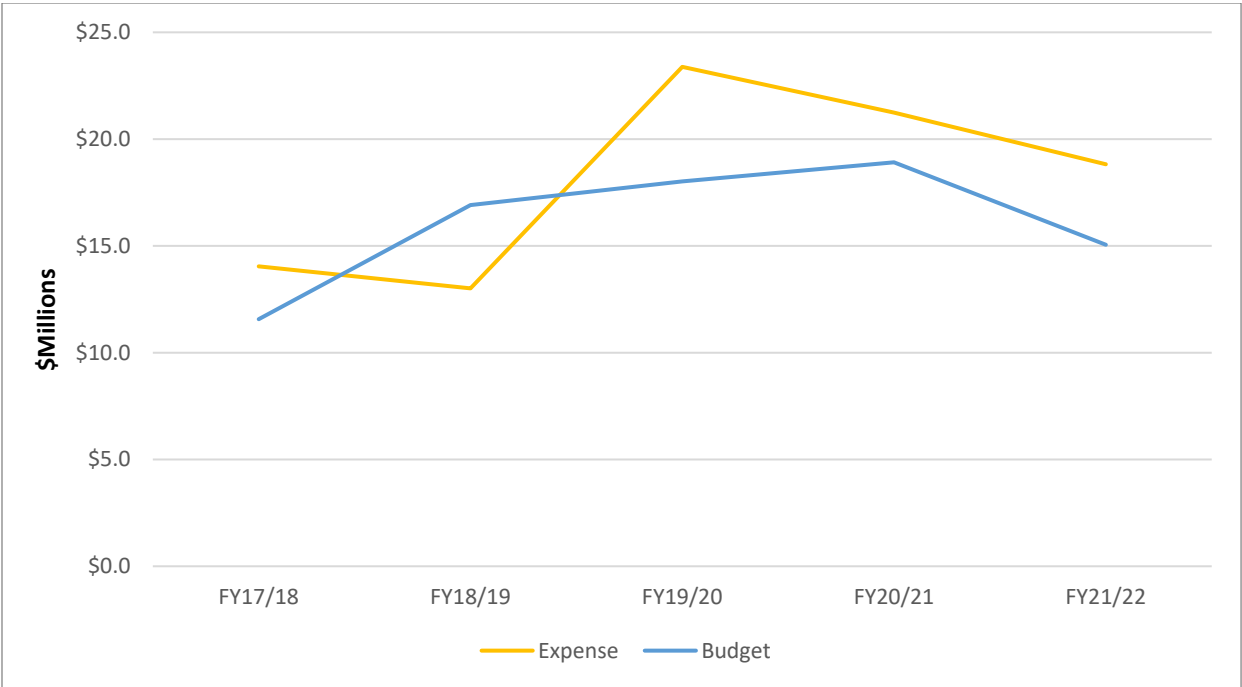
Figure 4-3. Five-Year Historical Maintenance Costs for Treatment Plants

Figure 4-3 and Figure 4-4 show the historical actual spent versus budgeted operational and maintenance expenditures for the treatment plants and collection system, respectively.

- The treatment plant expenditures include maintenance services and materials (budget objects 54010, 54020).
- The collection system expenditures include maintenance services and materials (budget objects 54010, 54020, 53180).
- These costs represent the operations and maintenance costs of fixed assets, including operationally funded repair/replacement projects.
